Date : 05/14/2026  
Project No : 2025C214  
Client Company : Artisan  
Arrival Time : 05/14/2026 13:00  
Onsite Hours : 03:30

ASEC Report ID : 94423  
Name of the Project : NW Unit 4 BRIDGE (Materials Testing)  
Project Location : Dallas  
Weather : Sunny  
Departure Time : 05/14/2026 16:30  
ASEC Technician Name : Clyde Smith

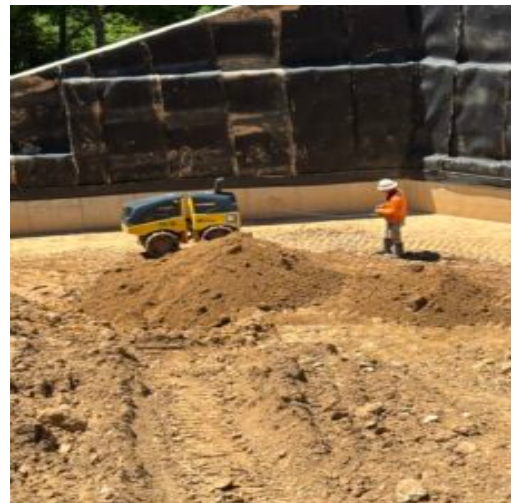
On the above date our representative was on site to observe backfilling at the northside bridge abutment. The contractor began backfilling using on site stockpiled materials. These soil materials appear to be 5% to 7% over optimum which will be difficult to achieve the required compaction. The writer stood by to observe backfilling as the contractor continued to have equipment problems with onsite repairs being made.

Beginning backfill at wall with equipment failure
