Date : 07/13/2026  
Project No : 2025C215  
Client Company : Artisan  
Arrival Time : 07/13/2026 07:30  
Onsite Hours : 06:00

ASEC Report ID : 96204  
Name of the Project : NW Unit 4 Parkway Ext. Phase 1  
Project Location : Dallas  
Weather : cloudy  
Departure Time : 07/13/2026 13:30  
ASEC Technician Name : Clyde Smith

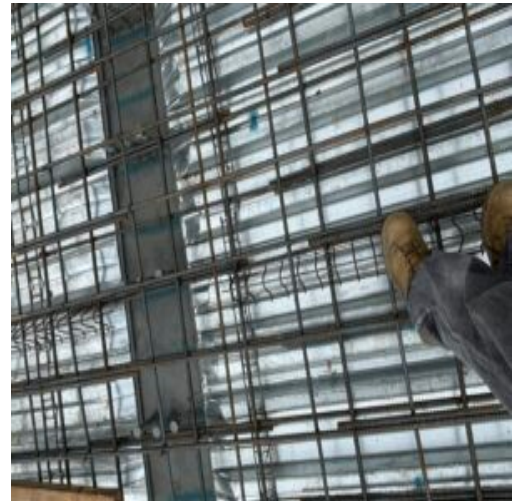
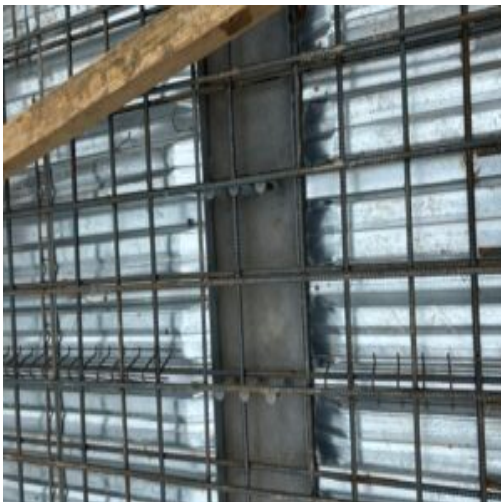
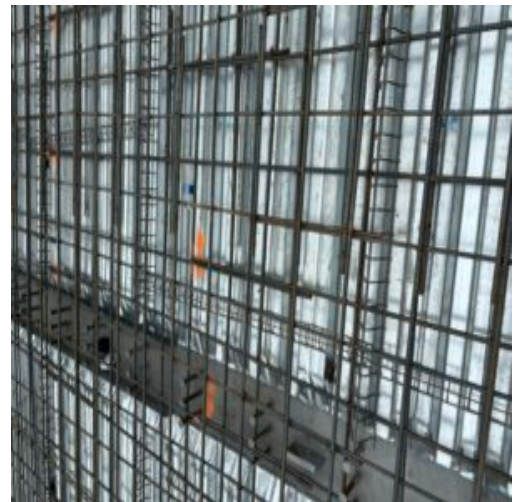
The writer also also observed the Wall contractor installing reinforcing steel at bridge panels.

Observation of reinforcing steel being installed at bridge panels

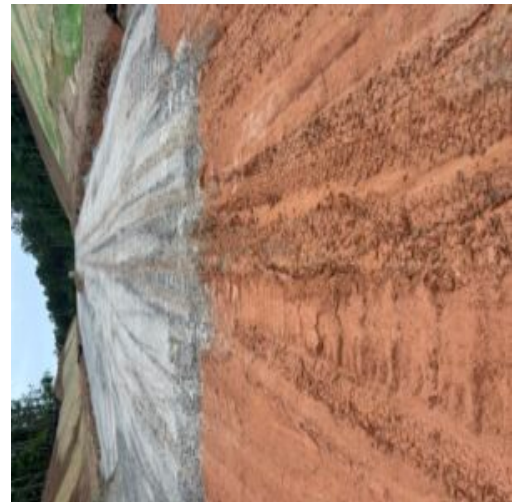
On the above date the writer was onsite as requested and met with the Paving contractor (NWGP) to observe sub grade and sub base conditions after recent rain event. The remaining sub grade approximately 150' both sides of roadway appeared too wet with rutting observed from sub contractors traffic. With additional rain forecasted for today it was decided not to repair and place additional base stone on today. The Paving contractor reminded onsite setting grade stakes and blading roadway.

Observation of sub grade after rain event at Nature  
Walk
