ASEC Report ID : 96326  
Name of the Project : NW Unit 4 Parkway Ext. Phase 1  
Project Location : Dallas  
Weather : cloudy  
Departure Time : 07/21/2026 14:30  
ASEC Technician Name : Clyde Smith

As requested, the site was visited by our AS Engineering and Consulting (ASEC) representative for the purpose of providing quality control inspection and testing services. Visual observation techniques were employed to verify compliance with project drawing/specifications, applicable codes, and materials submittals. The following observations were observed on site this day.

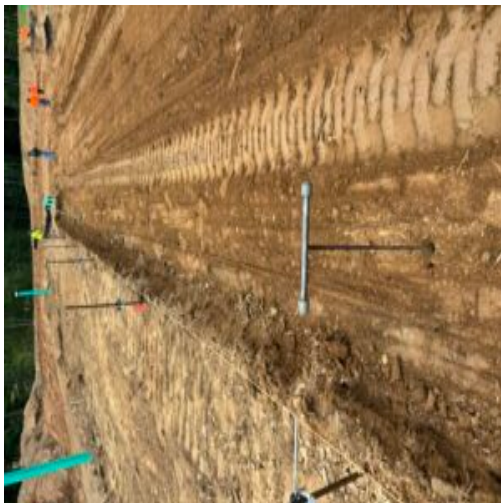
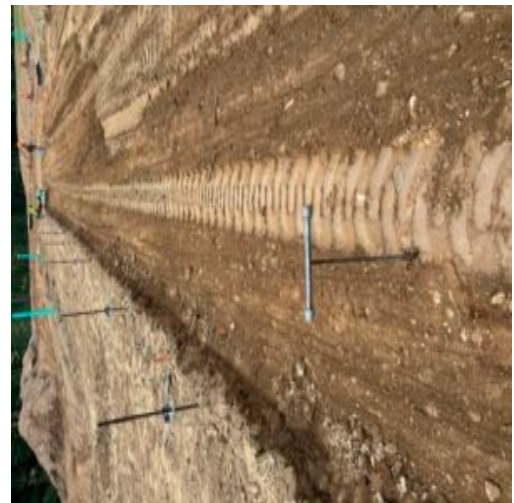
The curbing contractor J&W was onsite at Seven Hills phase 13 setting up for a curbing pour at the roadway past the gas line crossing. The writer observed subgrade soils by probing using a 3/8" diameter rounded end steel rod. Most areas observed appeared to be above optimum moisture contents with estimated in-place compaction results ranging from 90% to 92%. The contractor has elected to pour curbing at these current conditions.

Probe rod depths -8" to -16"

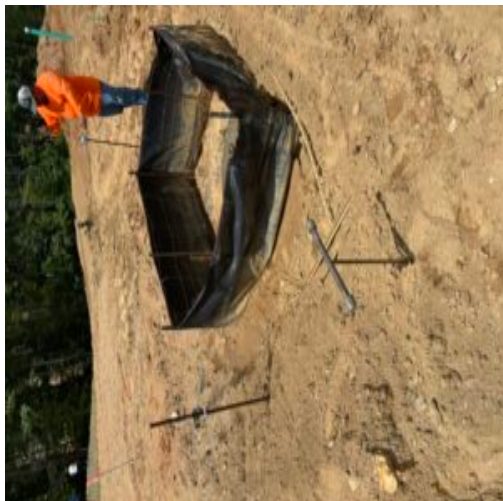
On the above date our representative was onsite to continue observing the paving contractor (NWGP) perform subbase preparation and subgrade repair for Naturewalk Parkway west side of sanitary sewer manhole #12. The contractor undercut existing subgrade soils as recommended, removing saturated subgrade soils that displayed severe rutting. The contractor placed 285.05 tons of base stone for the undercut with contract stone included in this total. The contractor also is filling in eroded reels at curb line from a previous rain event. The curb line replacement will require proof-rolling prior to pouring curbing.

Sub base prep.at Nature Walk Pkwy.
