Date : 08/25/2026  
Project No : 2026C101  
Client Company : Artisan  
Arrival Time : 08/25/2026 07:30  
Onsite Hours : 07:00

ASEC Report ID : 97167  
Name of the Project : Seven Hills PHASE 13, UNIT 3 Lots  
Project Location : Dallas  
Weather : Sunny  
Departure Time : 08/25/2026 14:30  
ASEC Technician Name : Clyde Smith

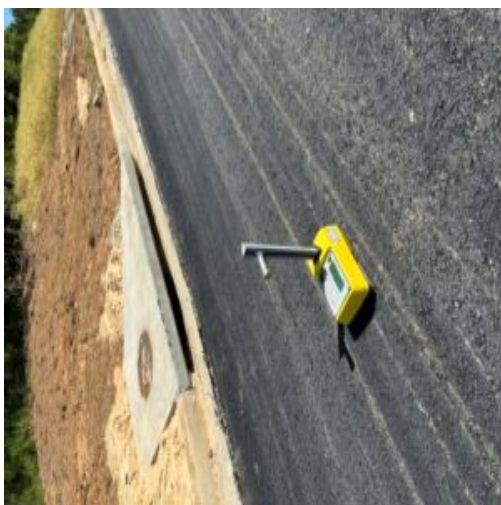
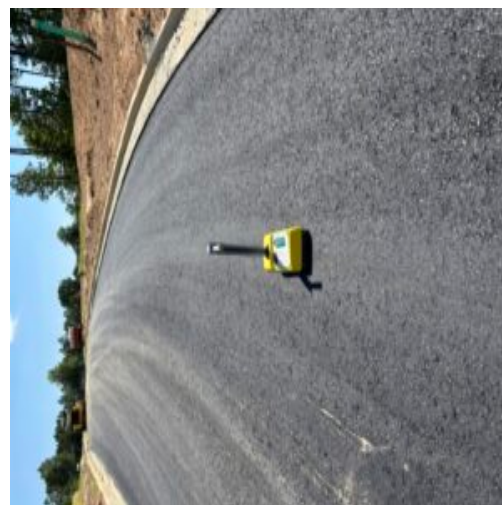
The writer observed asphalt 19mm SP binder mix placed at roadway on 8/25/26 by performing density checks using a Troxler Nuclear gauge model 3430, serial no. 91643. Results were 136.5, 139.1, 136.5, 139.0, 135.3, 141.6, 143.6, 142.6, 140.6, 144.1, 142.0, 139.4 and 144.2, all pcf. During paving placement there was no additional information provided (specific gravity or theoretical value). Based on an estimated value of 152.0 pcf compaction efforts would range between 90% and 93%. The lower compaction efforts were located near the Plantation Gas lines crossing. These results were reported to the paving contractor.

Density checks performed on 19mm SP asphalt binder on 8/24/26

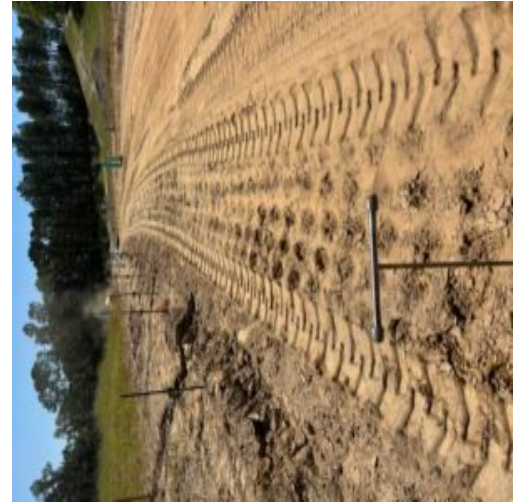
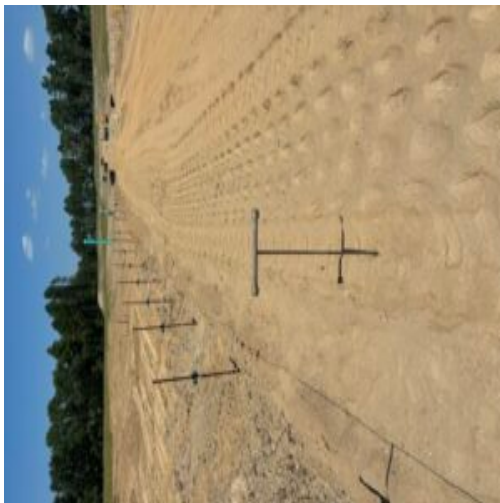
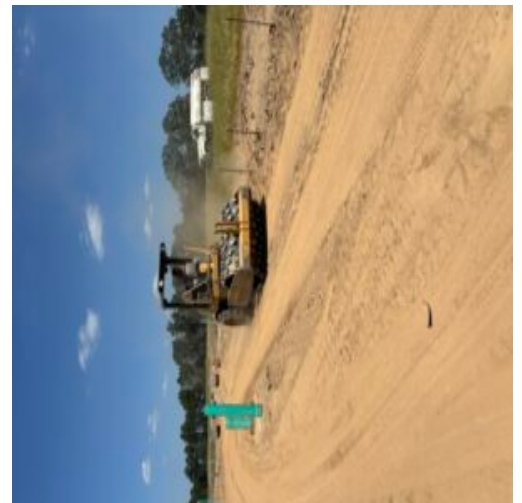
The writer also observed subgrade conditions for curbing at Unit 4 Phase 2 main section of roadway by probing using a rounded end steel rod. Several areas were observed having loose compacting efforts with recommendations made to recompact existing subgrade soils prior to curbing placement. The writer reobserved subgrade soils after additional compacting efforts were made and approved subgrade soils for curb placement.

Observation of sub grade for curbing at Unit 4 Phase 2 with recompactng efforts
