Date : 05/10/2023  
Project No : 2022C106  
Client Company : CWM  
Arrival Time : 05/10/2023 8:00  
Onsite Hours : 10:00

ASEC Report ID : 59213  
Name of the Project : Taxiway 2022 Pavement Replacement  
Project Location : HJAIA  
Weather : sunny  
Departure Time : 05/10/2023 18:  
ASEC Technician Name : Aminullah Azimi

## Daily Field Report

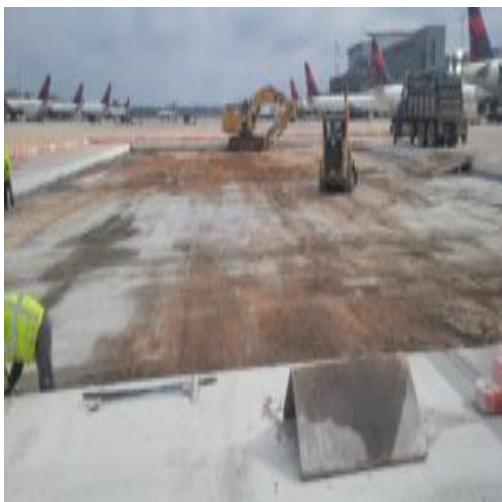
- Pre-pour observation performed in the Ramp 2 phase 4, Lane 2 and lane 4 portions of the project on this day. Contractor completed rebar and dowel basket placement for these lanes.

- The contractor cleaned loose rock and debris and standing water from the base.
- Baskets were found to be level, straight and secured.
- Dowel bars were found to have epoxy. Embedment length appeared to be 15 inches into concrete.

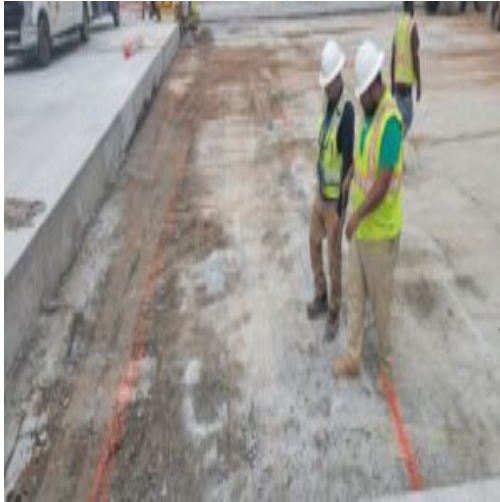
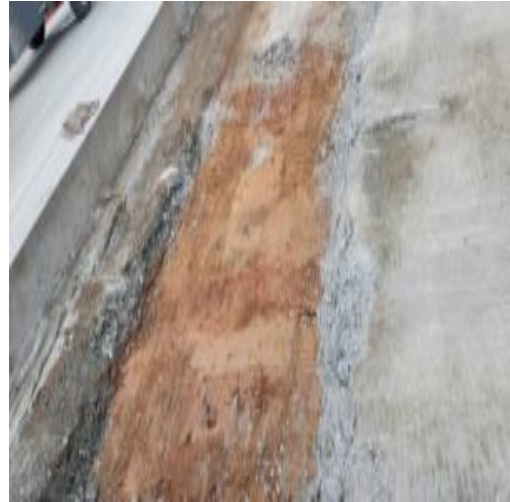
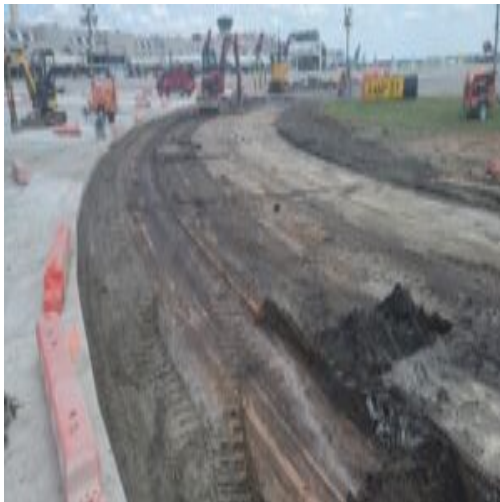
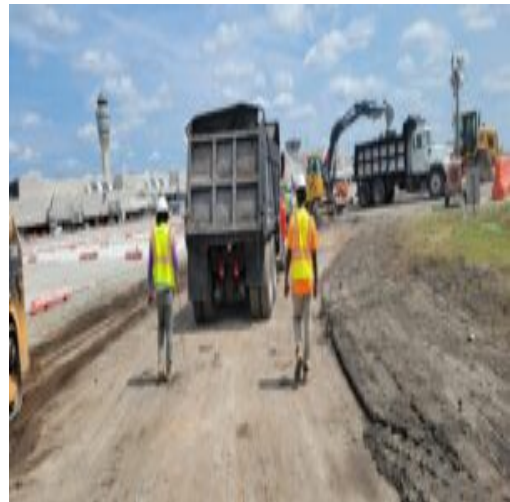
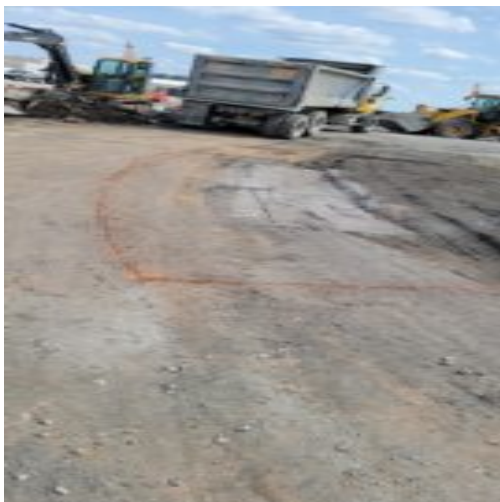
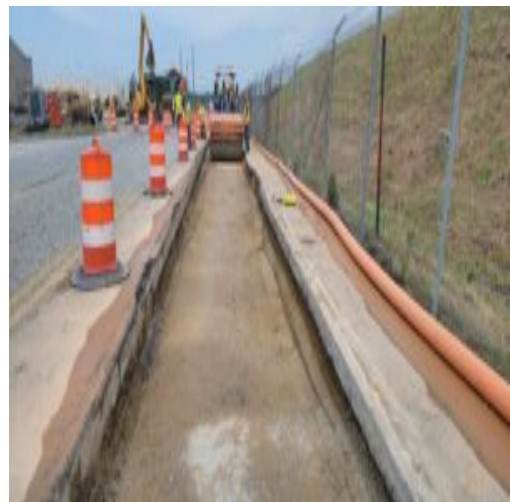
- At this time the panels were removed and the subgrade appears to have been milled and adjusted to proposed bottom of concrete elevation.
- A fully loaded tandem axle truck was used to proof-roll the above the mentioned subgrade with multiple passes across the area. The subgrade appeared to be unyielding and little to no deflection was observed during the proof-roll in this area. Except a small area in SE corner (6×30) feet was yielding QC recommended, under cut 8 inches and replaced with structural fill or GAB.
