Date : 08/26/2023  
Project No : 2022C218  
Client Company : CWM  
Arrival Time : 08/26/2023 8:00  
Onsite Hours : 12:00

ASEC Report ID : 61085  
Name of the Project : Ramp 20  
Project Location : HJAIA  
Weather : sunny  
Departure Time : 08/26/2023 20:00  
ASEC Technician Name : Aminullah Azimi

Upon request from the client's representative, our team at AS ENGINEERING AND CONSULTING, LLC (ASEC) conducted a site visit to oversee and monitor the contractor's work activities for quality assurance. The aim was to ensure compliance with project specifications, drawings, relevant codes, and materials submissions. Additionally, our team conducted quality control (QC) testing in accordance with the project's plans and specifications. The following observations were noted during this site visit:

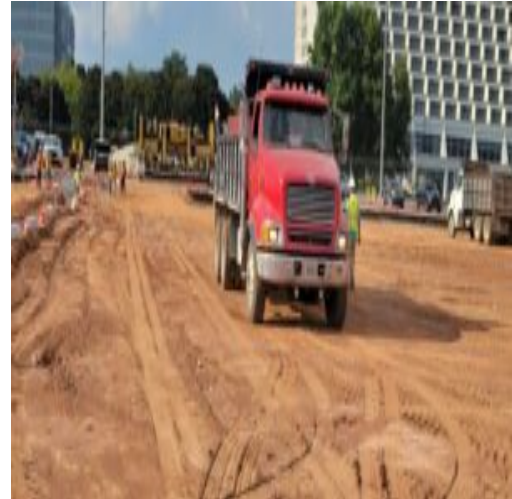
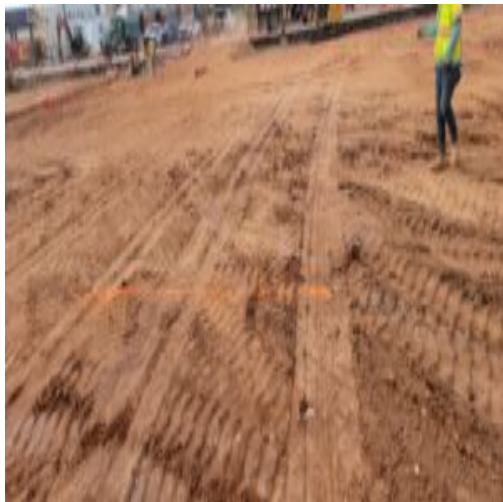
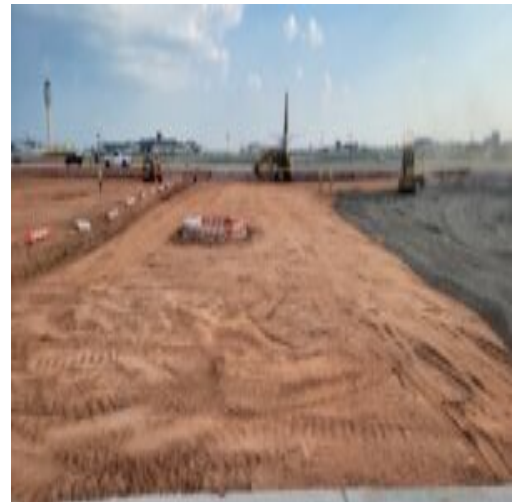
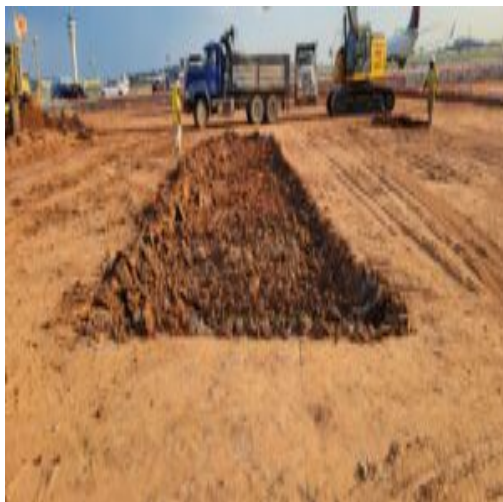
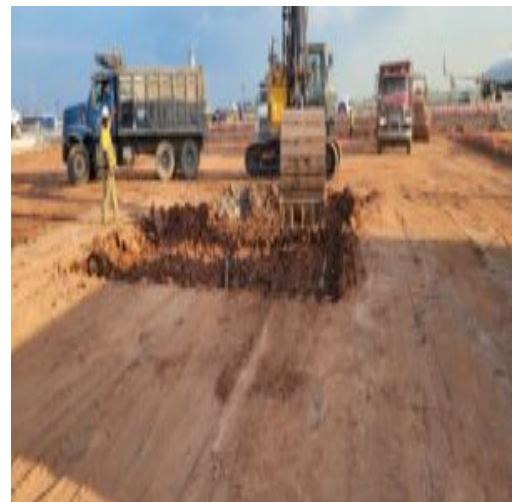
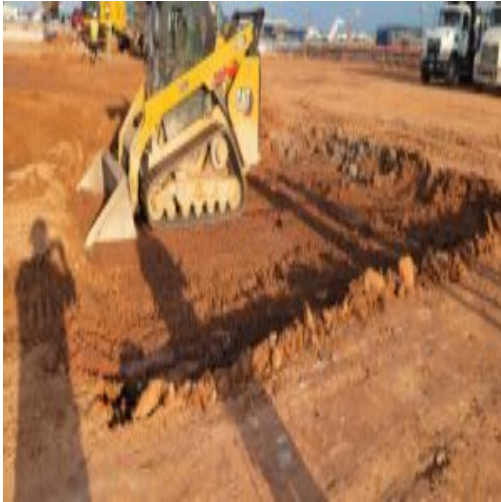
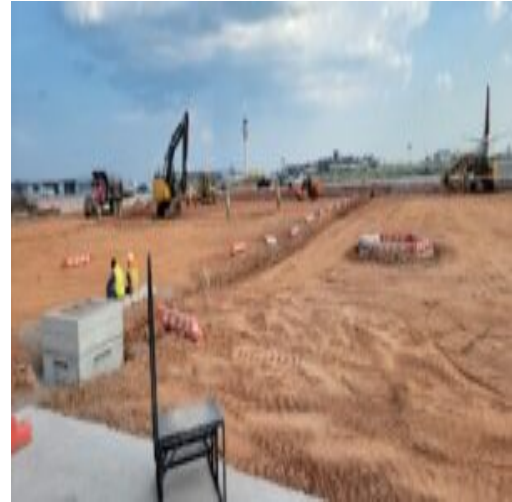
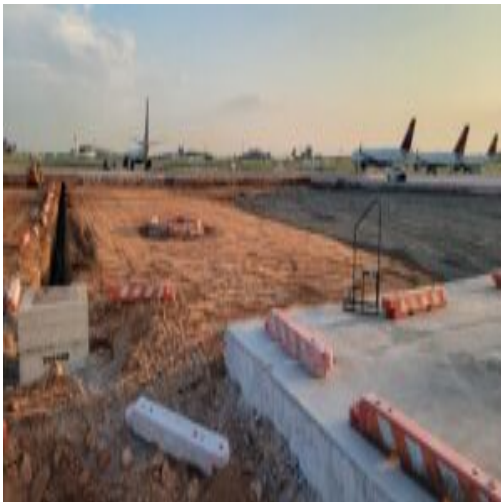
1. A proof-roll observation was executed in specific areas: Ramp 20, Northeast corner, and the Central portion of phase 2.
2. To carry out the proof-roll, a fully loaded tandem-axle dump truck was utilized. This truck made multiple passes across the aforementioned subgrade areas.
3. The entire area assessed appeared to be unyielding and acceptable for further construction except in four specific areas, as indicated below:

- Area D: Notable issues were identified in an area measuring 150 square feet. The coordinates for this area are N 9642.2, E 11781.6; N 9642.2, E 11794.8; N 9630.9, E 11794.1; N 9630.2, E 11781.5.
- Area E: Irregularities were found in an area spanning 6405 square feet. The coordinates for this area are N 9802.1, E 11813.6; N 9696.4, E 11874.5; N 9637.4, E 11877.5; N 9630.4, E 11916.6; N 9614.6, E 11918.9; N 9613.8, E 11807.3.
- Area F: Issues were observed in an area covering 651 square feet. The coordinates for this area are N 9735.5, E 11984.4; N 9735.2, E 12006.1; N 9705.8, E 12007.3; N 9705.8, E 11984.9.
- Area G: Deficiencies were identified in an area of 870 square feet. The coordinates for this area are N 9789.3, E 12011.8; N 9785.5, E 12028.4; N 9729.2, E 12028.3; N 9729.1, E 12014.9.

Based on these observations, it was recommended to address the issues by excavating to a depth of 6 inches and replacing with well placed structural fill.
