ASEC Report ID : 63836  
Name of the Project : DOA Fiber Infrastructure Improvements  
Project Location : HJAIA  
Weather : windy/ clear night  
Departure Time : 01/29/2024 06:00  
ASEC Technician Name : Isaac Davis

## Project Report: RTR Tower - Fiber Duct Bank Density Tests

- **Location:** RTR Tower
- **Scope:** Fiber Duct Bank Placement between Sierra and Mike 14
- **Section Length:** 50 feet

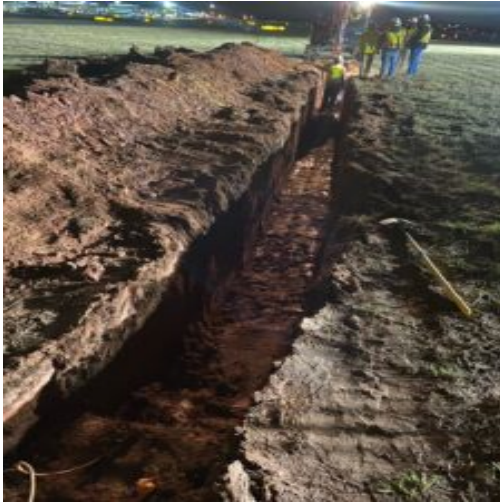
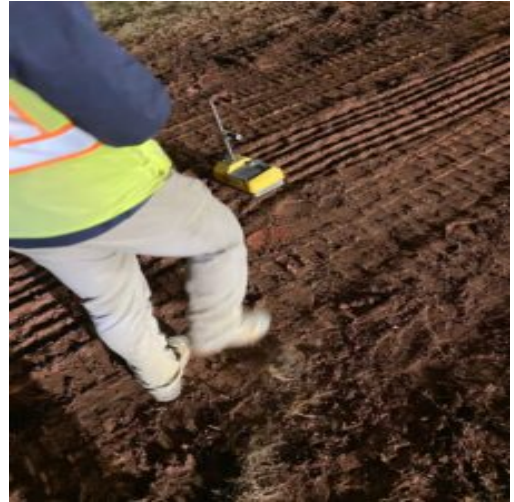
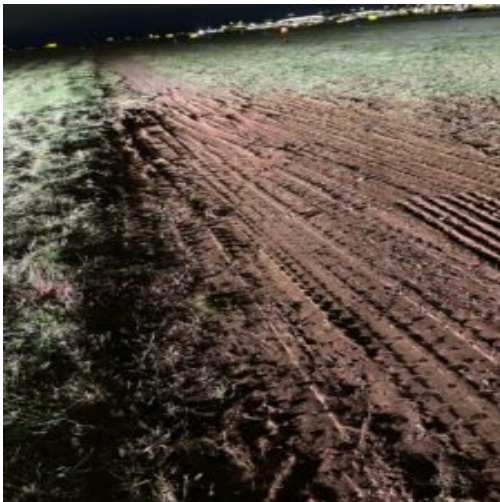
- Both density tests were conducted on the precast duct bank section between Sierra and Mike 14.
- Test #1 exhibited a wet density of 117.0 lb/ft<sup>3</sup> and a dry density of 87.5 lb/ft<sup>3</sup>, with a moisture content of 33.6% and compaction of 78%.
- Test #2 showed improvements with a wet density of 119.8 lb/ft<sup>3</sup> and a dry density of 91.5 lb/ft<sup>3</sup>. The moisture content reduced to 30.8%, and the compaction increased to 82%.
