ASEC Report ID : 63709  
Name of the Project : DOA Fiber Infrastructure Improvements  
Project Location : HJAIA  
Weather : clear night  
Departure Time : 01/18/2024 06:00  
ASEC Technician Name : Isaac Davis

## Density Report for Jobsite - RTR Fiber (Tower Duct Bank)

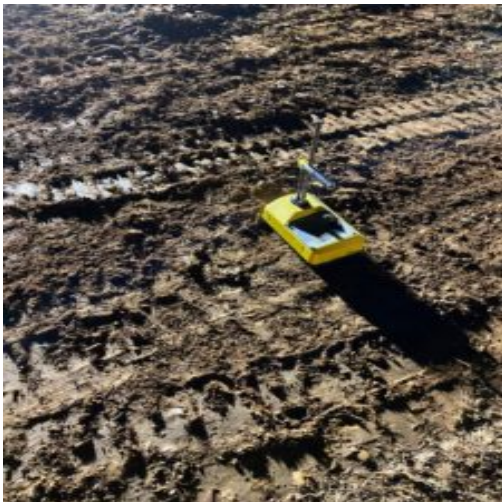
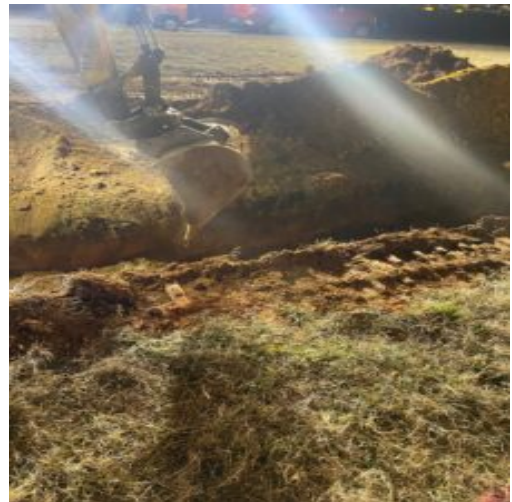
- Trench excavation, pre-cast duct bank placement, and backfilling have been executed according to project specifications.
- Preliminary test results indicate density and moisture content, with further analysis pending the acquisition of the proctor.

- Depth: The trench was excavated to an approximate depth of 4 feet.
- Quality: The excavation process aimed to meet the required specifications for the subsequent installation of the duct bank.

- Design: The pre-cast duct bank is designed to accommodate two-way 4-inch pipes.
- Dimensions: Each pre-cast duct bank segment measures approximately 1 foot in height and 10 feet in length.
- Placement: The duct bank segments were properly positioned within the excavated trench.
