ASEC Report ID : 60598  
Name of the Project : Carodel Farms @ Union Church Rd  
Project Location : Flowery Branch  
Weather : Cloudy  
Departure Time : 07/28/2023 17:30  
ASEC Technician Name : Vidal Shengan

Our AS Engineering and Consulting (ASEC) representative visited the Carodel Farms site to conduct quality control inspection and testing services. Visual observation techniques were employed to ensure compliance with project drawing/specifications, applicable codes, and materials submittals. The following observations were made on-site:

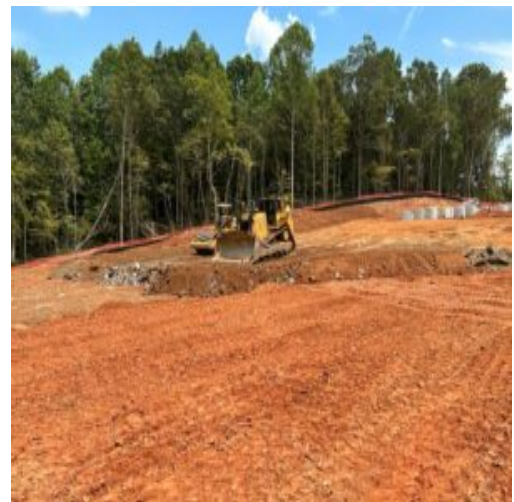
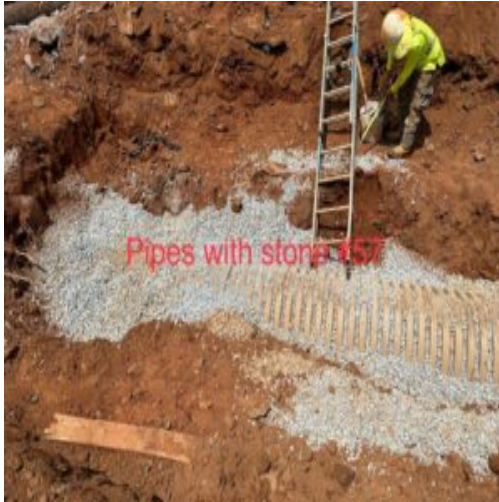
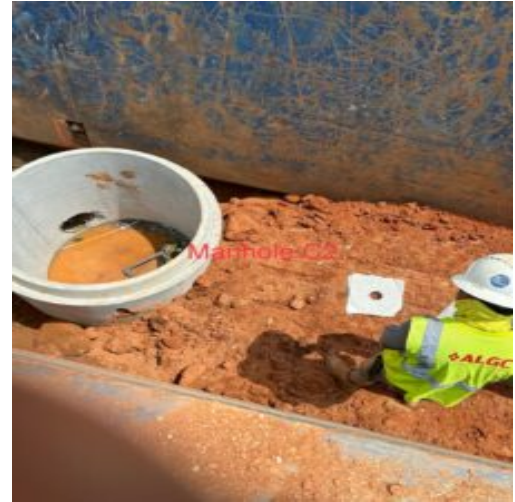
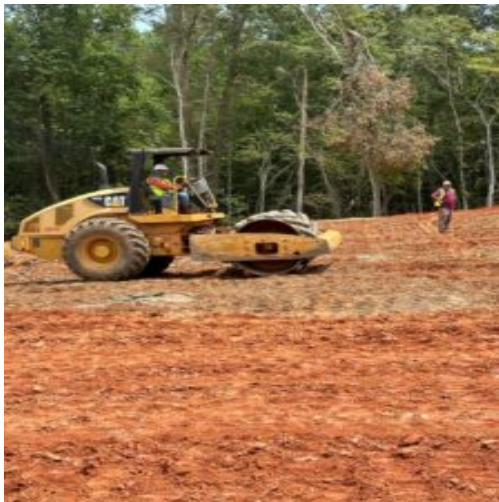
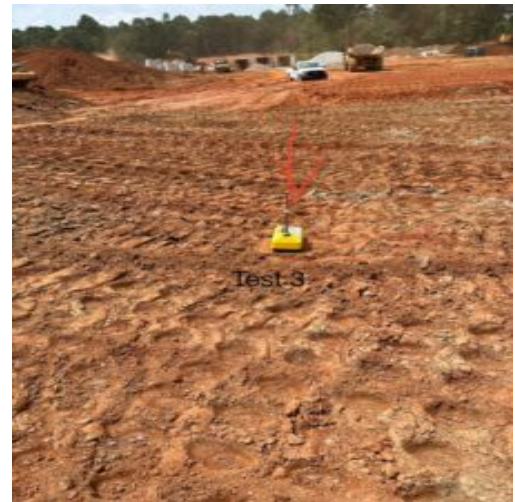
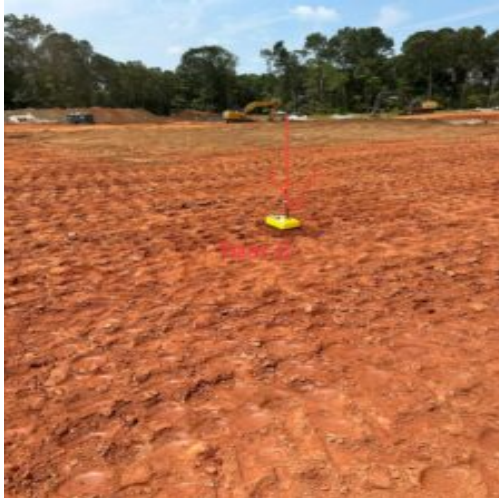
1. Installation of manhole C-2: The contractor installed manhole C-2 with 4 inches of #57 stone placed at the bottom prior to manhole installation. The quality control representative visually inspected the installation and verified that it met the project requirements.

2. Installation of HDPE Pipe: Between manhole C-2 and manhole C-1, the contractor installed HDPE (High-Density Polyethylene) pipe. Prior to placing the pipe, the contractor prepared the bottom with 4 inches of #57 stone followed by a 4-inch layer of stone cover once the pipe was placed. The quality control representative visually assessed the installation and confirmed that it was executed according to the project specifications.

3. Backfilling Operations: The contractor placed backfill for the open space zone x and on Lot #106 to Lot #112. The depth of placement was 6 feet below finished grade. Density tests were taken for Lots #107, 109, 112. Compaction was performed using a CP56 compactor. Testing results indicate that the compaction met the project requirements.

4. Drilling Operations: Driller 1 drilled a total of 72 holes with a drilled area of 3528 cubic feet. The hole spacing length was 7 feet by 7 feet, and the hole diameter was 3.5 inches. The quality control representative monitored the drilling operations and confirmed that they were conducted safely and efficiently.
