Date : 05/28/2026  
Project No : 2023C159  
Client Company : CW Matthews  
Arrival Time : 05/28/2026 22:00  
Onsite Hours : 08:00

ASEC Report ID : 94838  
Name of the Project : Airfield Repairs 2021-23  
Project Location : HJAlA, Atlanta, GA  
Weather : clear  
Departure Time : 05/29/2026 06:00  
ASEC Technician Name : Samara Simha Reddy Kandi

## **Core Locations and Measurements**

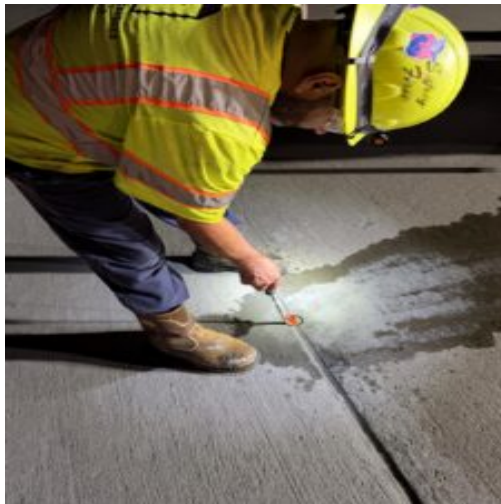
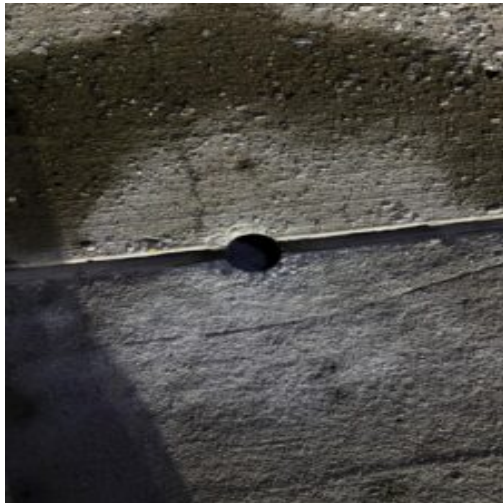
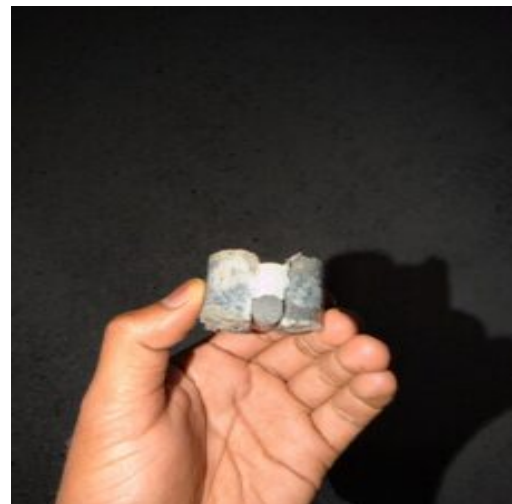
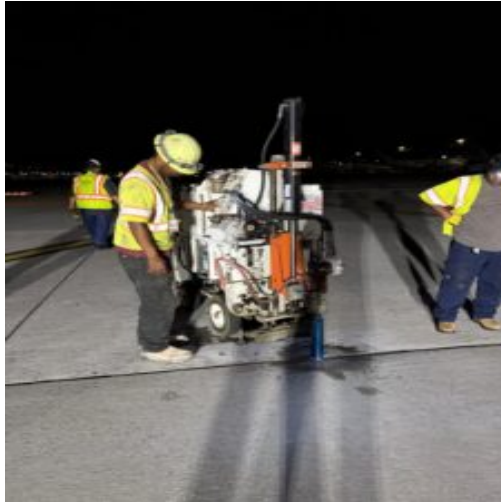
Designated locations for coring were marked and core drilling operations were performed using a core cutter at each selected joint location. After drilling, the core samples were carefully removed, measured for joint width and thickness, labeled for identification, and documented for reporting purposes. The drilled holes were then cleaned using compressed air to remove loose debris and dust. After cleaning, foam backer rod and silicone sealant were installed, and all openings were sealed following completion of the coring activities.

A total of 18 cores were obtained from various locations across the project area. Of these, 17 cores were taken from construction joints and 1 core was taken from an expansion joint.
