ASEC Report ID : 66341  
Name of the Project : Sterlington  
Project Location : Canton  
Weather : sunny  
Departure Time : 05/03/2024 18:00  
ASEC Technician Name : Aminullah Azimi

The undersigned arrived onsite to observed CMU block retaining wall #1 placement.

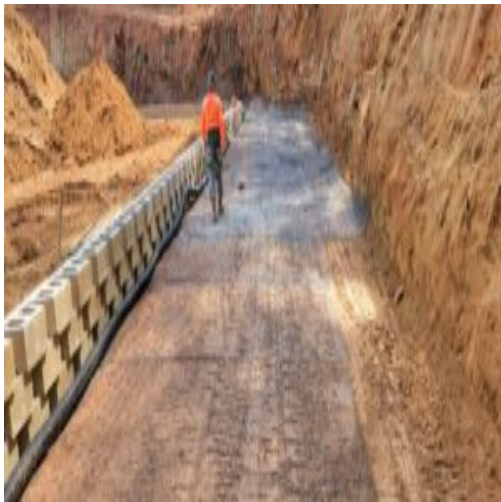
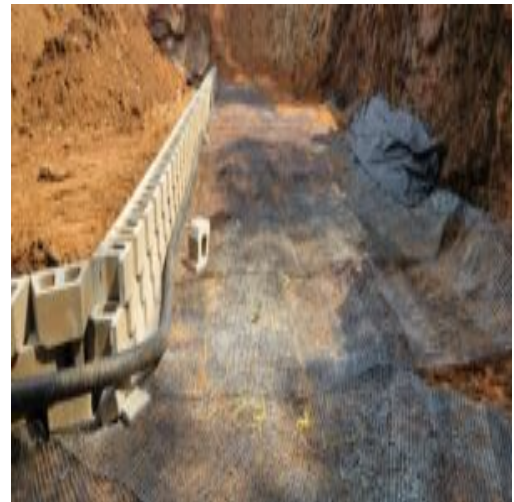
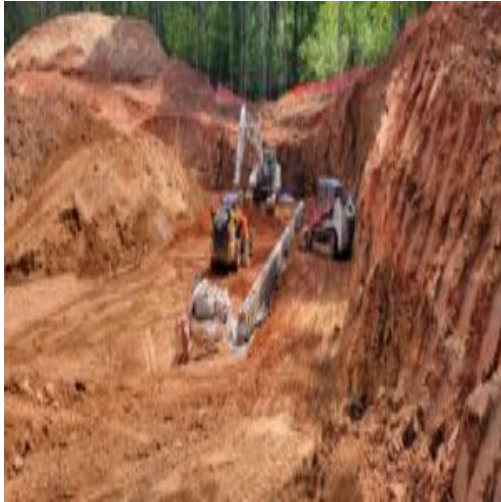
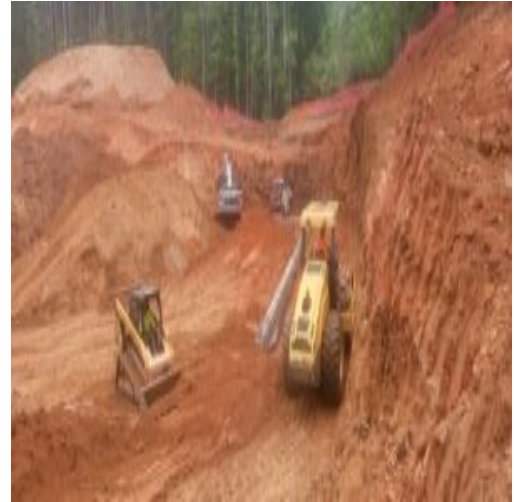
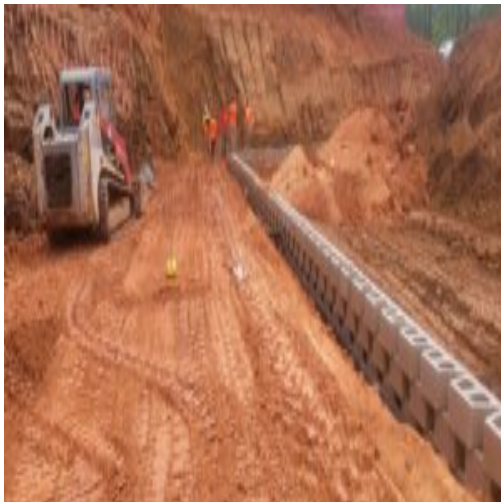
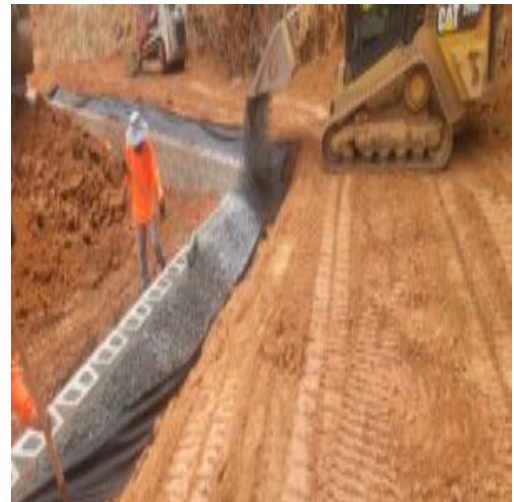
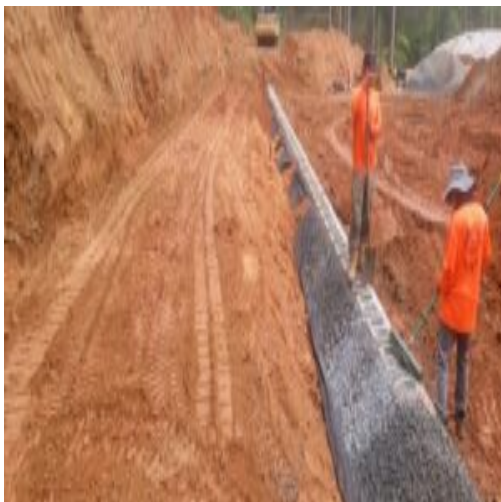
The undersigned noted the base course was placed behind the block and in the cells with #57 stone.

Every 3rd course of block, a geotextile reinforcement was placed (Geo-grid). Soil backfill was placed in 12-inch lifts and compacted using 12 ton pad-foot and trench compactor.

No. 57 stone was utilized 1 foot behind the block and within the cells.

A drainage pipe outlet (weep hole) was installed every 50 feet.
