Date : 05/28/2026  
Project No : 2025C149  
Client Company : Davidson Homes  
Arrival Time : 05/28/2026 11:  
Onsite Hours : NaN:00

ASEC Report ID : 95344  
Name of the Project : Grove at E. Thompson Mill Rd  
Project Location : Buford  
Weather : clear and sunny  
Departure Time : 05/28/2026 5  
ASEC Technician Name : Narayana Ganesh Undavalli

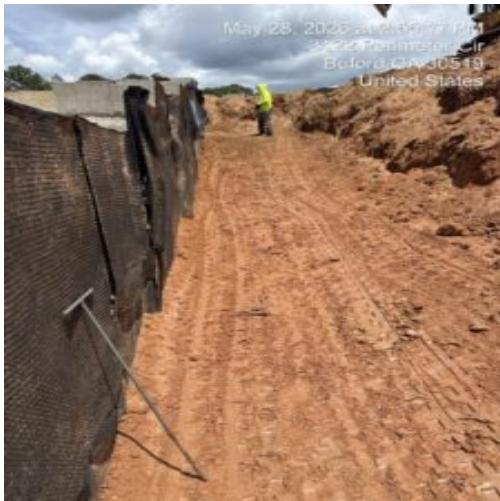
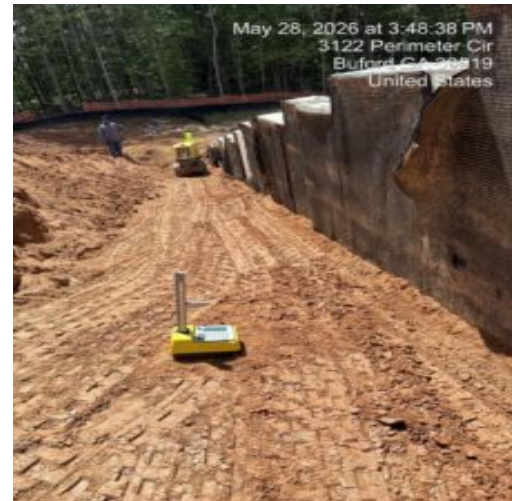
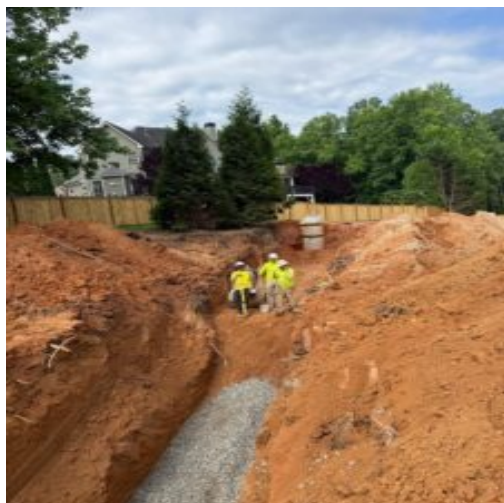
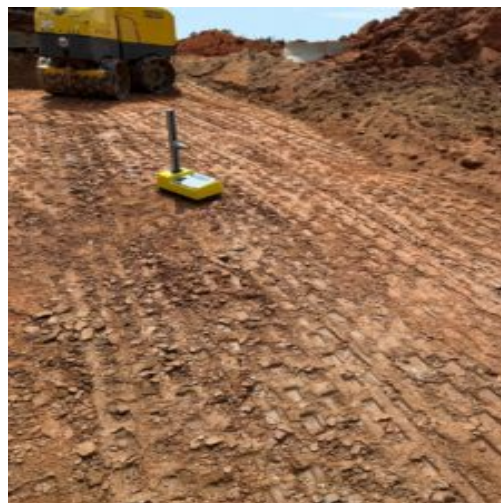
Crew continued working beside retaining wall #1. Fill material was placed in lifts, spread using a crawler bulldozer, and compacted using both a sheep-foot roller and a Caterpillar815. Density tests were performed, and the results met the required project compaction specifications.

At the neighborhood site the crew started excavation and placing storm drainpipe and placed No.57 stone around the drainpipe and fill material was then placed and compacted using a sheep-foot roller.

At the Buford neighborhood site, the crew continued trench excavation using a hydraulic excavator equipped with a rock grinder to achieve the required depth and width.
