Date : 02/08/2024  
Project No : 2022C165  
Client Company : Toll Bros. Inc.  
Arrival Time : 02/08/2024 8:30  
Onsite Hours : 03:00

ASEC Report ID : 64061  
Name of the Project : Northfield @ Polo Fields - Phase2  
Project Location : Pittman Road, Cumming, GA  
Weather : sunny  
Departure Time : 02/08/2024 11:30  
ASEC Technician Name : Aminullah Azimi

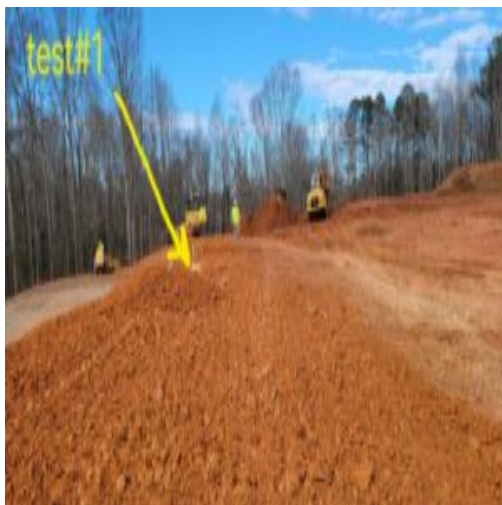
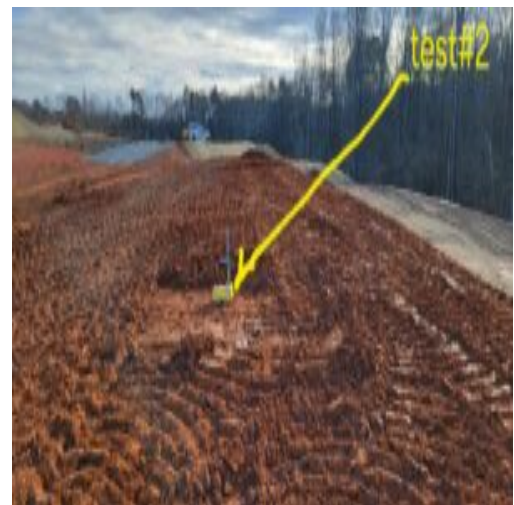
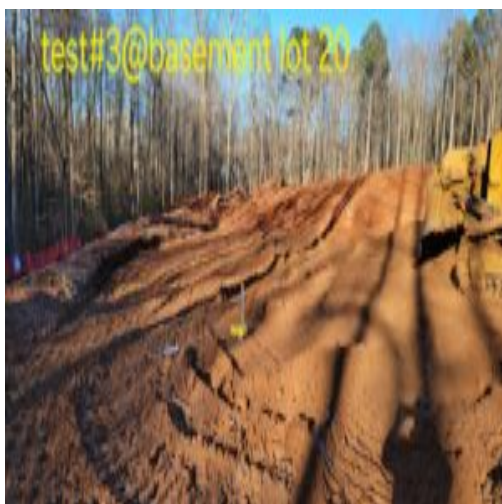
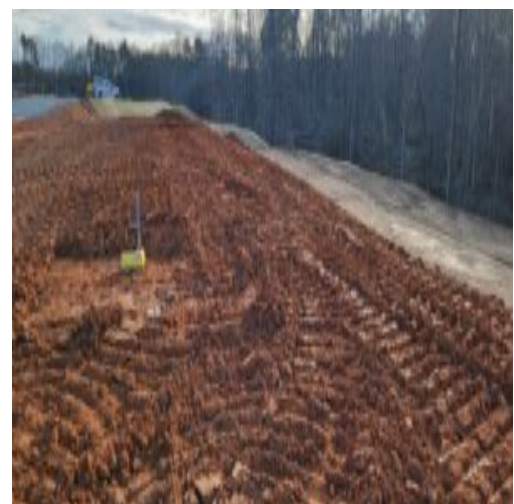
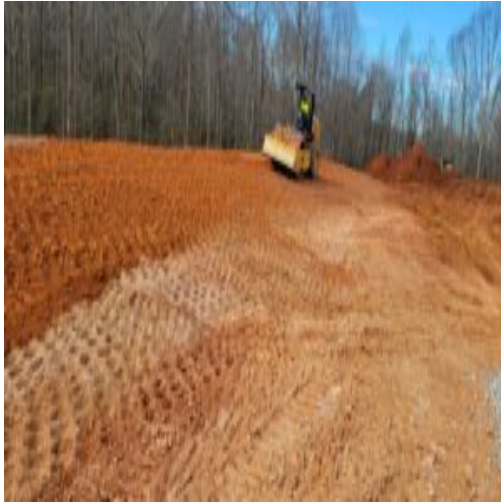
- The placement and compaction of fill soils for Lot #21, Lot #22 and Lot #23, continued this day.
- At the time of arrival, our representative observed that work was in progress with 1-foot lifts being placed and compacted using a sheep-foot (CP56B) compactor.
- Density test results indicate that the compacted materials met the project requirement of 90% of the maximum dry density obtained by the (Standard Proctor ASTM 698),
