ASEC Report ID : 57207  
Name of the Project : Lakes at Statham  
Project Location : Barrow County  
Weather :  
Departure Time : 02/15/2023 16:00  
ASEC Technician Name : Russell Hendrix

Our AS ENGINEERING AND CONSULTING, LLC representative visited the site at the client's request to perform DCP testing on Lots #72, 73, 74, 75, and 76. Unconsolidated soft soils were encountered in the top 12 inches in Lots #74B, 76A, and 73C.

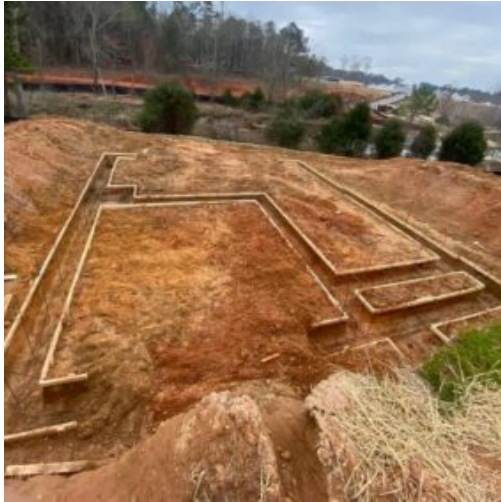
Lot 72

- 1- 13 Brown, Sandy SILT.
- 2- AR

- 1- 13- Brown, Sandy, SILT.
- 2- 7- Brown, Sandy, SILT.
- 3- 10- Gray, Sandy, CLAY.
- 4- 8- Gray, Sandy, CLAY.

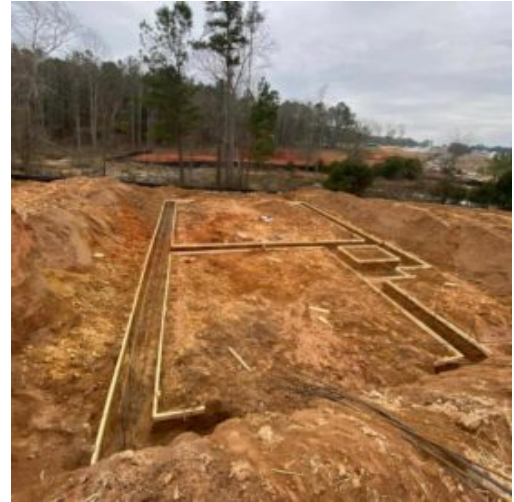
Lot 73

- 1- 1- Brown, Sandy SILT.
- 2- 3- Brown, Sandy SILT.
- 3- 6- Red, brown, Sandy SILT.
- 4- 18- Purple, brown, Sandy SILT.

- 1- AR

- 1- 6- Brown, Sandy CLAY.
- 2- 10- Brown, Sandy CLAY.
- 3- 12- Brown, Sandy SILT.
- 4- 16- Brown, Sandy SILT.

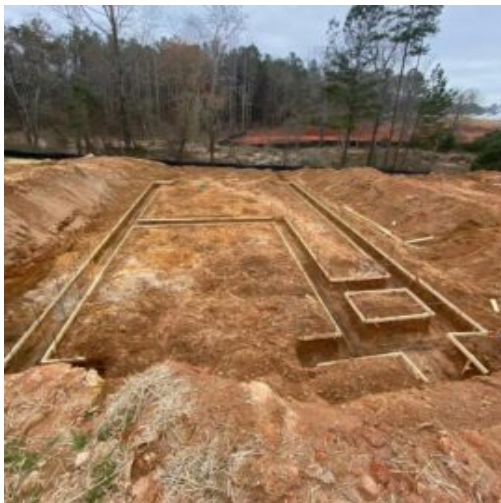
Lot 74

- 1- 7- Gray, Sandy CLAY.
- 2- 10- Brown, Sandy CLAY.
- 3- 8- Brown, micaceous, Sandy SILT.
- 4- 17- Brown, micaceous, Sandy SILT.

- 1- 3- Brown, micaceous, Sandy SILT.
- 2- 14- Red, brown, micaceous, Sandy SILT.
- 3- 9- White, brown, micaceous, Sandy SILT.

4- 20- White, micaceous, Sandy SILT.

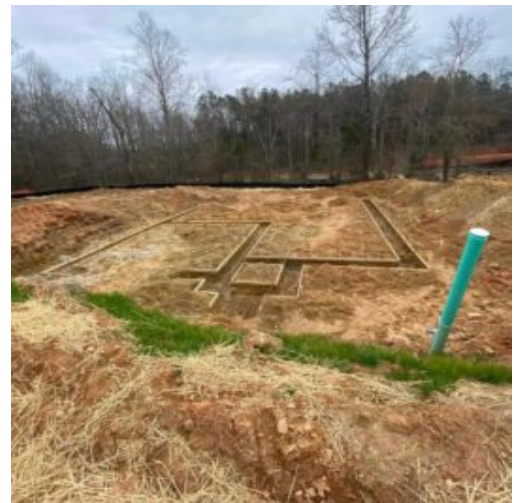
Lot 75

- 1- 13- Brown, micaceous, Sandy SILT.
- 2- 20- Brown, micaceous, Sandy SILT.
- 3- 20- Brown, micaceous, Sandy SILT.
- 4- 20- Brown, micaceous, Sandy SILT.

- 1- 8- Gray, Sandy CLAY.
- 2- 12- Brown, Sandy CLAY.
- 3- 13- Brown, micaceous, Sandy SILT.
- 4- 15- Brown, micaceous, Sandy SILT.

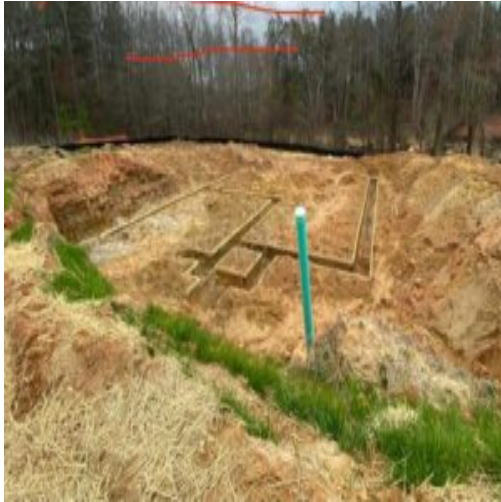
Lot 76

- 1- 8- Gray, Sandy CLAY.
- 2- 6- Gray, Sandy CLAY.
- 3- 6- Gray, Sandy CLAY.
- 4- 8- Gray, Sandy CLAY.

- 1- AR

- 1- 2- Red, Sandy SILT.
- 2- 3- Red, Sandy SILT.
- 3- 5- Gray, Sandy CLAY.
- 4- 5- Brownish red, CLAY.
