Date : 03/15/2023  
Project No : 2022C235  
Client Company : Jackson Demolition Service, Inc.  
Arrival Time : 03/15/2023 06:00  
Onsite Hours : 10:30

ASEC Report ID : 57825  
Name of the Project : Plant Gorgas Demolition and Grading  
Project Location : 460 Gorgas Rd, Parrish, AL 35580  
Weather : SUNNY  
Departure Time : 03/15/2023 16:30  
ASEC Technician Name : Vidal Dias

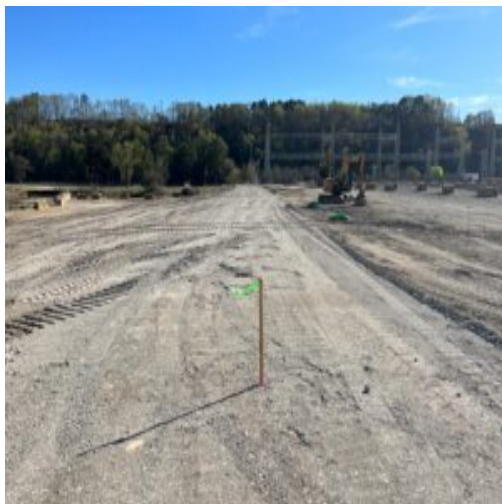
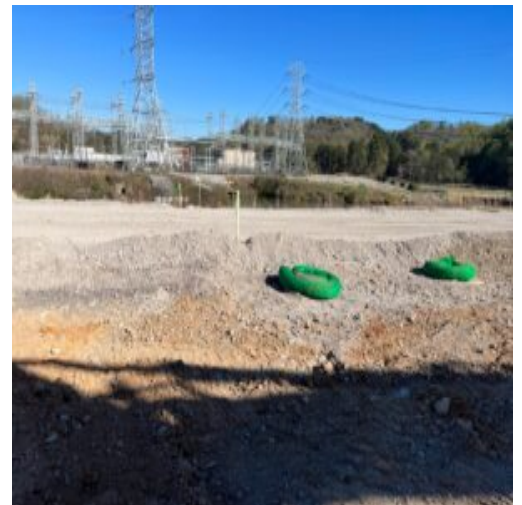
1. 612 Yards (18 loads) of clay materials were received and placed in the basement stationed at a sections H7 and H8.
2. The fill materials were placed and compacted in the basement in compliance with ITP-001.
3. 825B and crushed concrete were placed in sections H6 and G6 and compacted using CAT CS54B. The 825B was placed in compliance with ITP-003.

825B Place and compacted

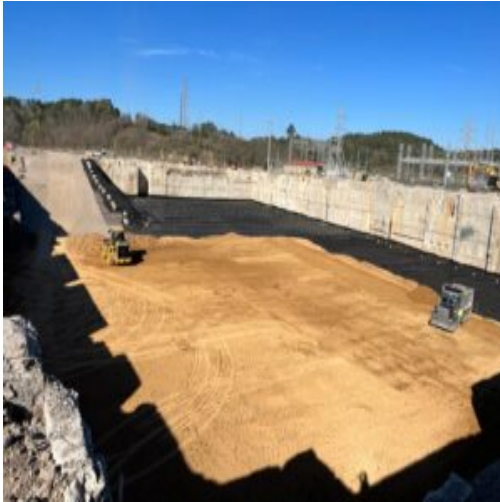
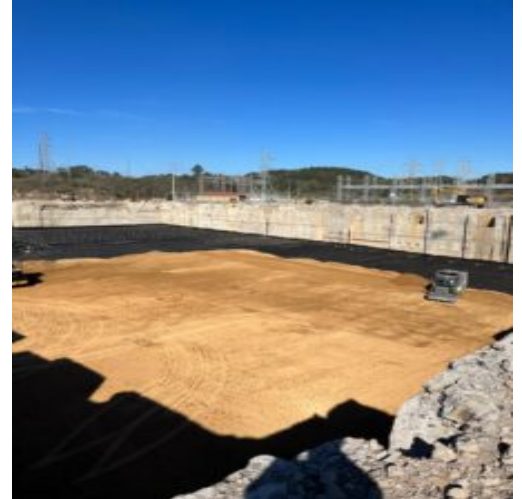
Placement of Fill material and compacted using CAT 815 in the basement.
