ASEC Report ID : 58598  
Name of the Project : Plant Gorgas Demolition and Grading  
Project Location : 460 Gorgas Rd, Parrish, AL 35580  
Weather : Raining  
Departure Time : 04/13/2023 16:00  
ASEC Technician Name : Vidal Dias

Our AS ENGINEERING AND CONSULTING, LLC (ASEC) representative, Vidal Dias, visited the site at the request of Jackson Demolition representative Josh Kelly. The undersigned representative was present to observe, verify and document the ongoing project activities. (Reference drawing E720661 S1 - R5, E720659 S1-R5.)

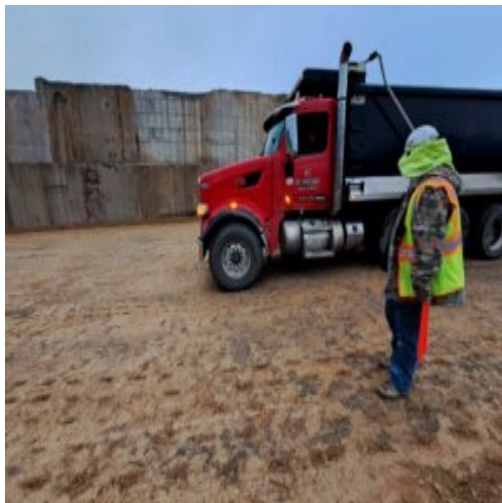
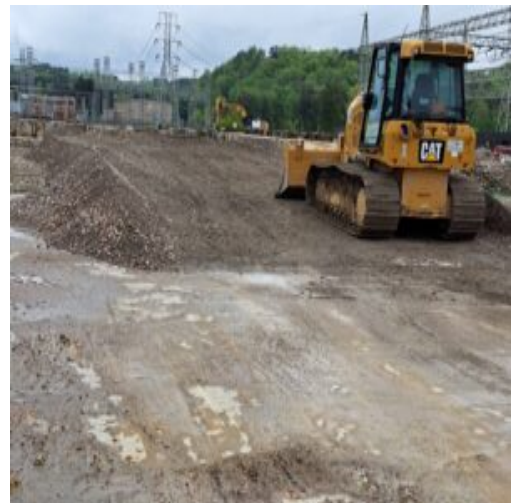
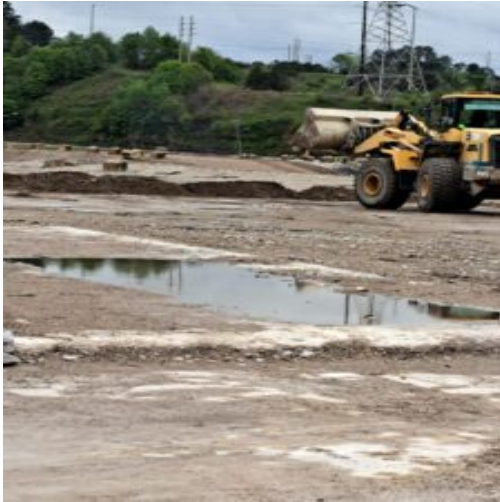
1. One hundred and twenty-six (126) cubic yards of fill materials were received for the purpose of lift four (4) in section 2 area G7 (drawing E720659) of the basement. The materials were placed in compliance with ITP-001.
2. A moisture test was performed, and the soils exceeded the required moisture limits.
3. A proof-roll was performed in the basement area H7 in section-1 at the ramp area.
