Date : 04/19/2023  
Project No : 2022C235  
Client Company : Jackson Demolition Service, Inc.  
Arrival Time : 04/19/2023 06:00  
Onsite Hours : 10:00

ASEC Report ID : 58679  
Name of the Project : Plant Gorgas Demolition and Grading  
Project Location : 460 Gorgas Rd, Parrish, AL 35580  
Weather : Sunny  
Departure Time : 04/19/2023 16:00  
ASEC Technician Name : Vidal Dias

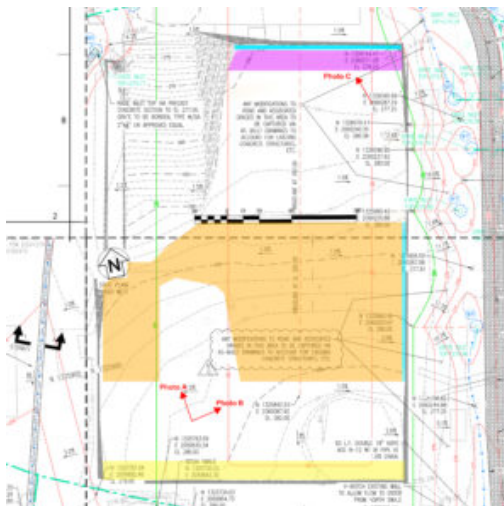
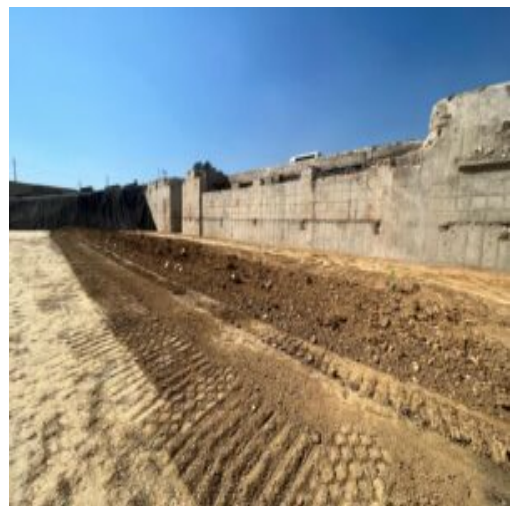
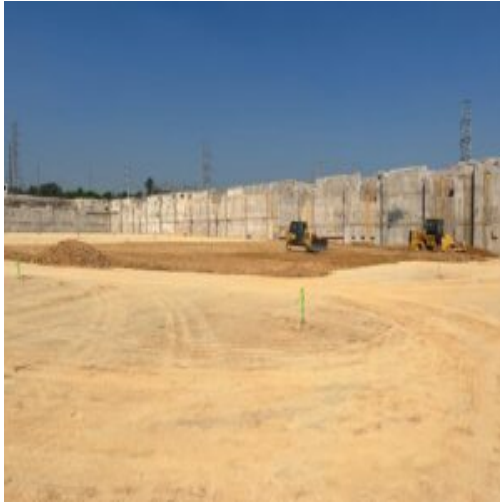
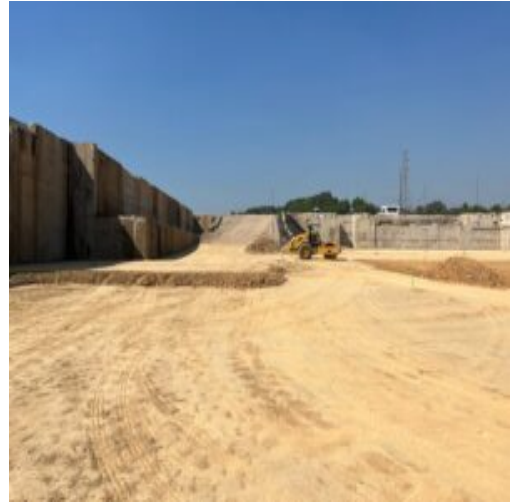
Photo documentation and test locations are attached:

1. One thousand four hundred seventy-six (1476) cubic yards of fill material were received and placed in section two of the basement area H7, H8, G7 & G8 (drawing E720659). The fill placement area is shown in *orange* on the attached drawing. The materials were placed in accordance with ITP-001.
2. Two moisture content tests were performed in section two. The first was performed at 9 am; moisture content was 15%. The second was performed at 3 pm, moisture content measured 13%. Water was applied to the area to maintain optimum moisture levels.
3. Continuous compaction occurred along the edges of the basement walls using the walk-behind vibratory compactor; the area is highlighted in blue.
4. Saturated soils near the northern wall were dispersed evenly to facilitate aeration. A moisture content test will be performed on the area in 24 hours. The area is highlighted in purple.
