Date : 04/26/2023  
Project No : 2022C235  
Client Company : Jackson Demolition Service, Inc.  
Arrival Time : 04/26/2023 06:00  
Onsite Hours : 10:00

ASEC Report ID : 58894  
Name of the Project : Plant Gorgas Demolition and Grading  
Project Location : 460 Gorgas Rd, Parrish, AL 35580  
Weather : Partly Cloudy  
Departure Time : 04/26/2023 16:00  
ASEC Technician Name : Vidal Dias

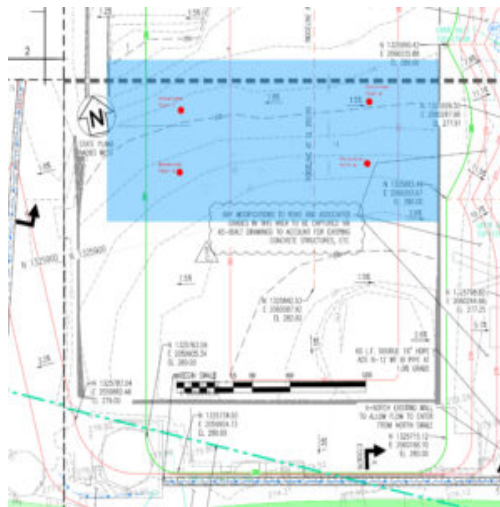
1. One thousand five hundred sixty-six (1566) cubic yards of fill materials were received and placed for lift six (6) in section 2 area G7 (drawing E720659) of the basement. The materials were placed in accordance with ITP-001, and the fill area is highlighted in blue on the attached drawing.
2. Four moisture tests were performed during the placement. The moisture test locations are labeled in red on the attached drawing.
