Date : 05/26/2023  
Project No : 2022C235  
Client Company : Jackson Demolition Service, Inc.  
Arrival Time : 05/26/2023 06:00  
Onsite Hours : 10:30

ASEC Report ID : 59517  
Name of the Project : Plant Gorgas Demolition and Grading  
Project Location : 460 Gorgas Rd, Parrish, AL 35580  
Weather : SUNNY  
Departure Time : 05/26/2023 16:30  
ASEC Technician Name : Avinash Bandham

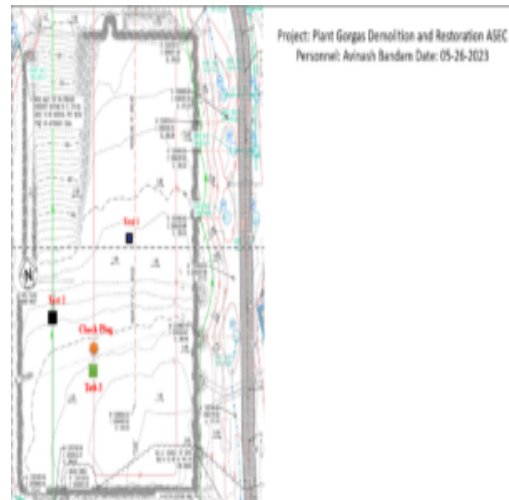
1. One thousand three hundred and four (1314) cubic yards of fill materials were placed for lift (11) in section 2 area G7 (drawing E720659) of the basement. The materials were placed in accordance with ITP-001.
2. Three density test and one check plug were performed in section 1 and section 2 basement areas B7 and G7 and the test locations are visible in the attached drawing.
