Date : 06/19/2023  
Project No : 2022C235  
Client Company : Jackson Demolition Service, Inc.  
Arrival Time : 06/19/2023 06:00  
Onsite Hours : 10:30

ASEC Report ID : 59807  
Name of the Project : Plant Gorgas Demolition and Grading  
Project Location : 460 Gorgas Rd, Parrish, AL 35580  
Weather : SUNNY  
Departure Time : 06/19/2023 16:30  
ASEC Technician Name : Avinash Bandham

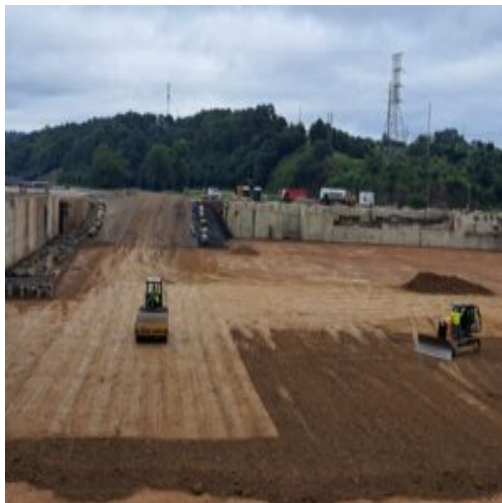
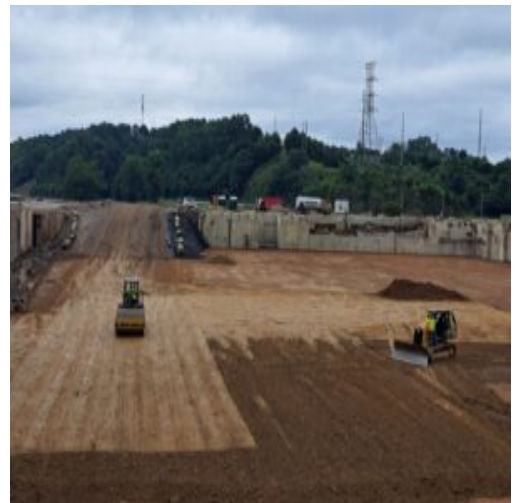
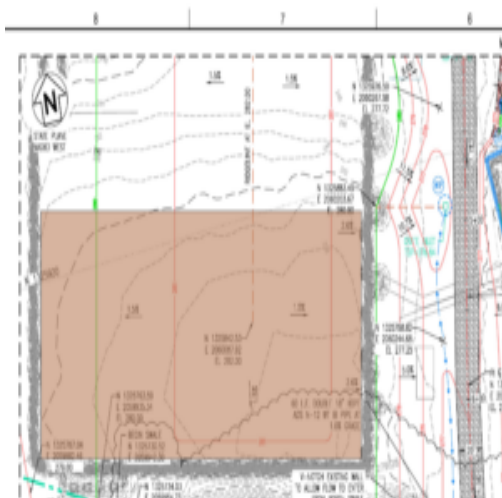
1. One thousand one hundred and eighty-eight (1188) cubic yards of fill materials were placed for lift (14) in section 2 area G7 (drawing E720659) of the basement. The materials were placed and compacted in accordance with ITP-001, and the fill area is highlighted in brown as depicted in the attached drawing.
