ASEC Report ID : 61519  
Name of the Project : Carodel Farms @ Union Church Rd  
Project Location : Flowery Branch  
Weather : sunny  
Departure Time : 09/12/2023 17:00  
ASEC Technician Name : Aminullah Azimi

As requested, the site was visited by our AS Engineering and Consulting (ASEC) representative for the purpose of providing quality control inspection and testing services, visual observation techniques were employed to verify compliance with project drawing/specifications, applicable codes, and materials submittals. The following observations were observed on site this day.

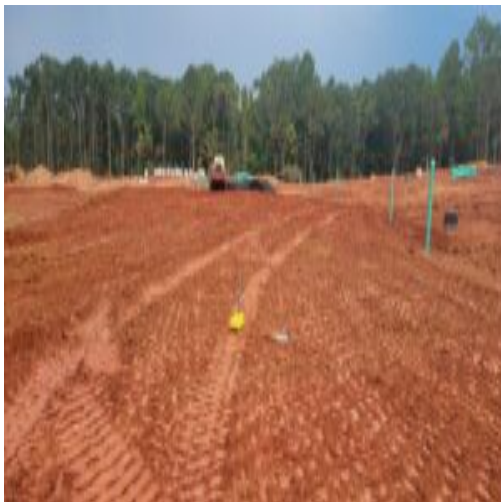
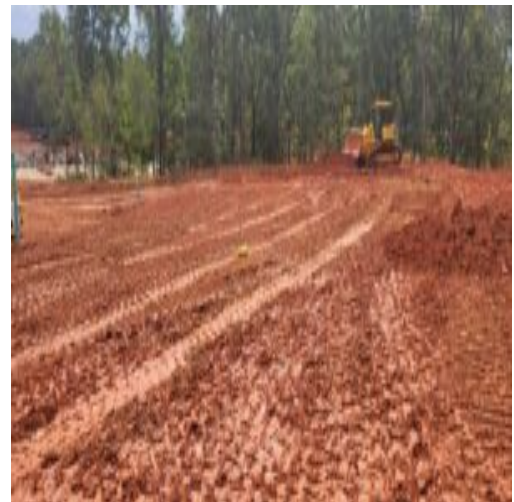
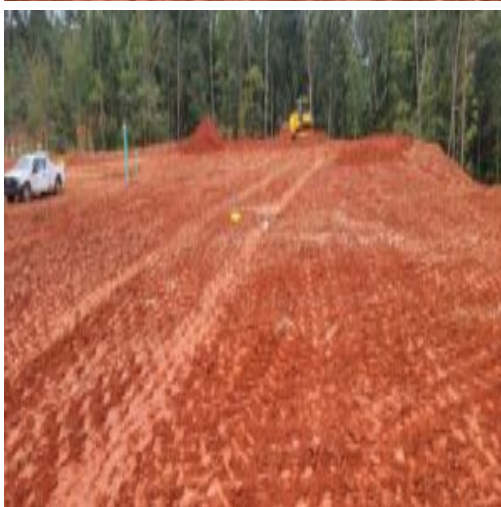
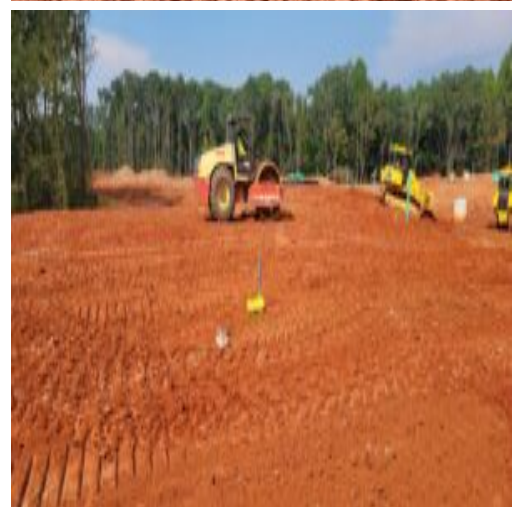
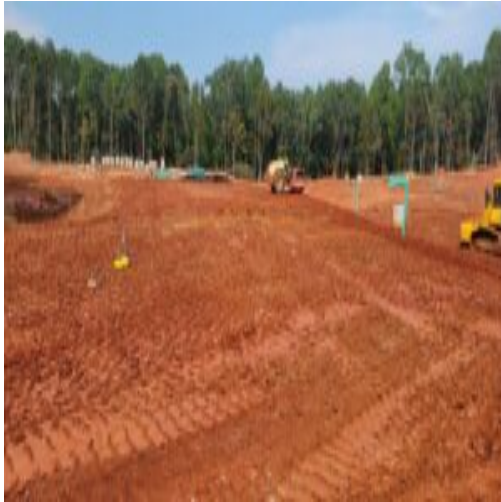
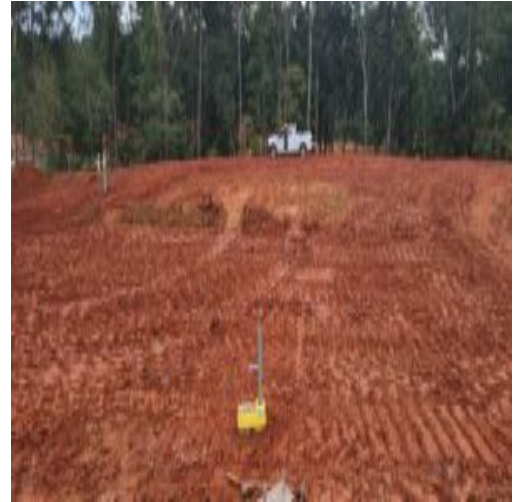
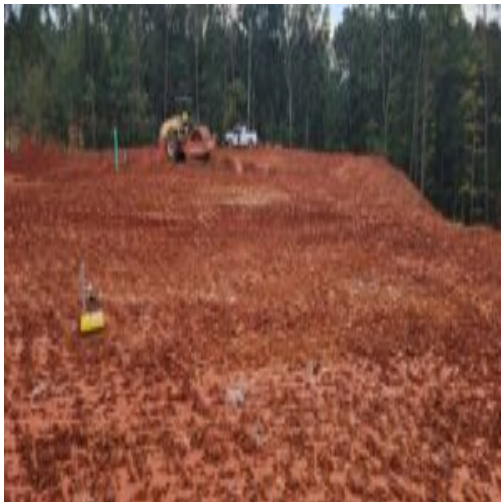
The placement and compaction of backfill soils for Lots #50, 51 and 52, continued this day.

At the time of arrival, our representative observed that work was in progress for lots with one (1) foot lifts being placed at finished grade and compacted using a 15-ton compactor.

Density test results indicate that the compacted materials met the project requirement of 95% of the maximum dry density.
