ASEC Report ID : 62212  
Name of the Project : Carodel Farms @ Union Church Rd  
Project Location : Flowery Branch  
Weather : sunny  
Departure Time : 10/03/2023 15:00  
ASEC Technician Name : Aminullah Azimi

As requested, the site was visited by our AS Engineering and Consulting (ASEC) representative for the purpose of providing quality control inspection and testing services. Visual observation techniques were employed to verify compliance with project drawing/specifications, applicable codes, and materials submittals. The following observations were observed on site this day.

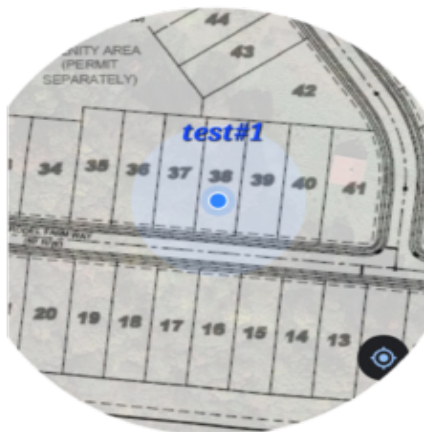
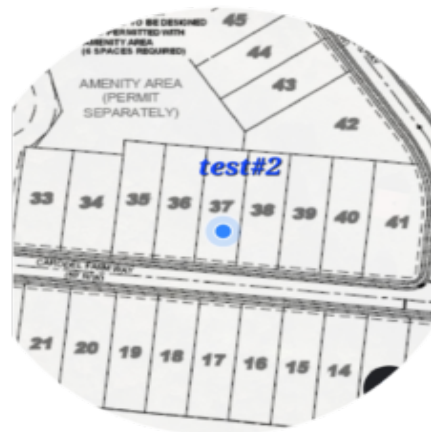
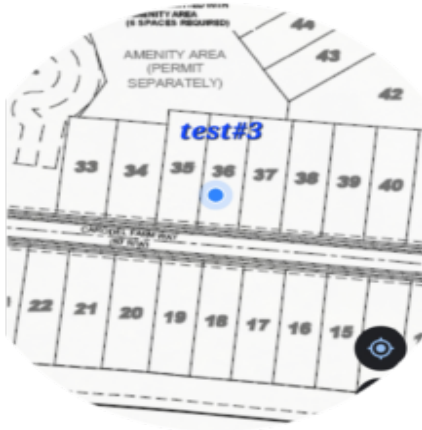
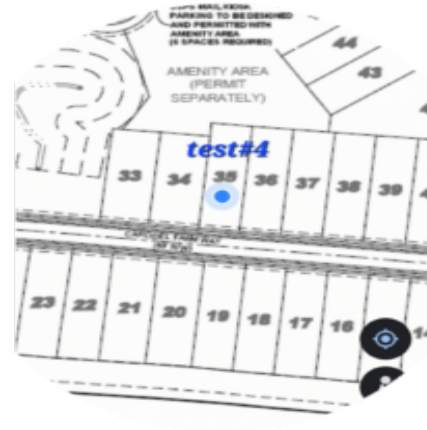
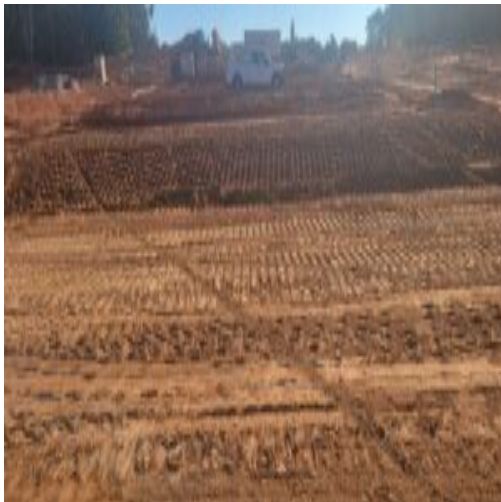
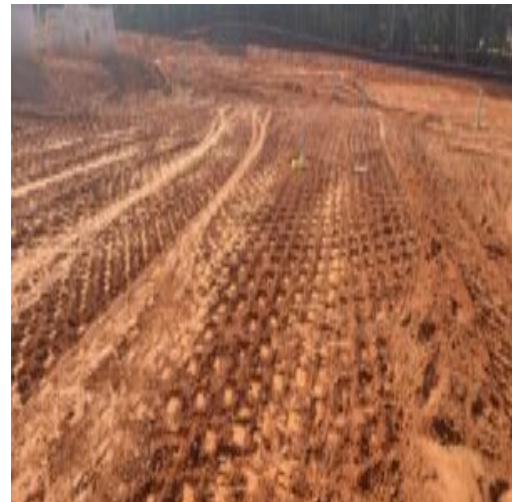
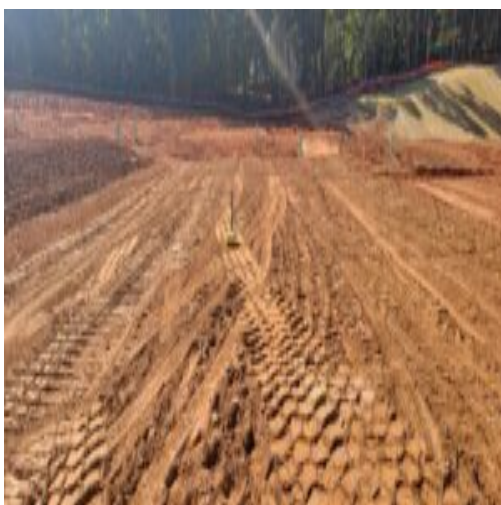
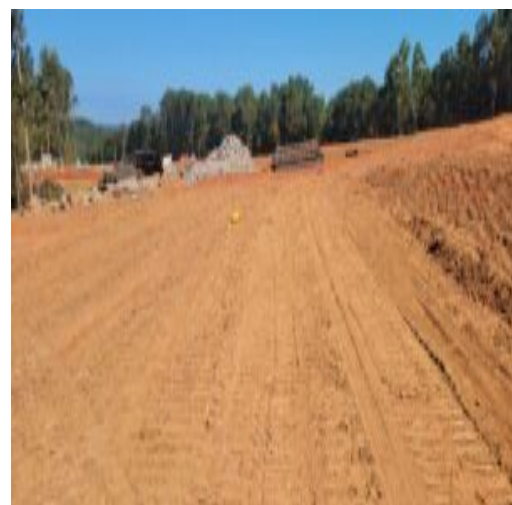
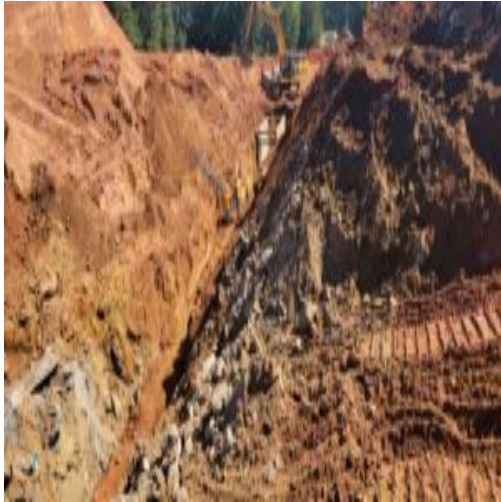
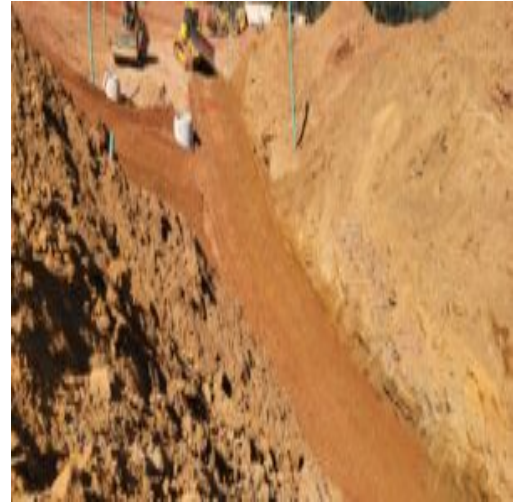
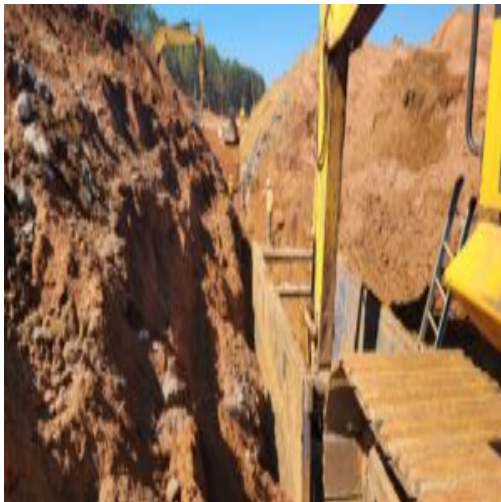
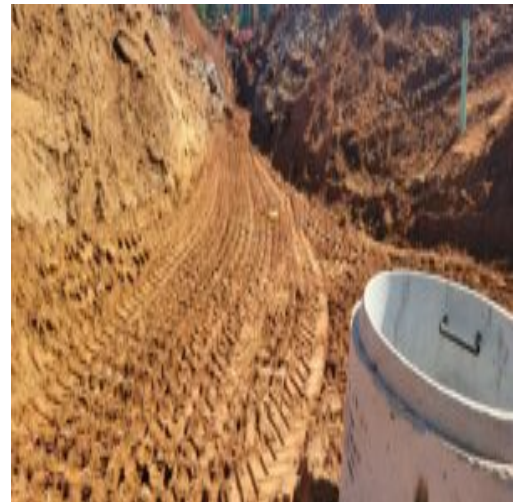
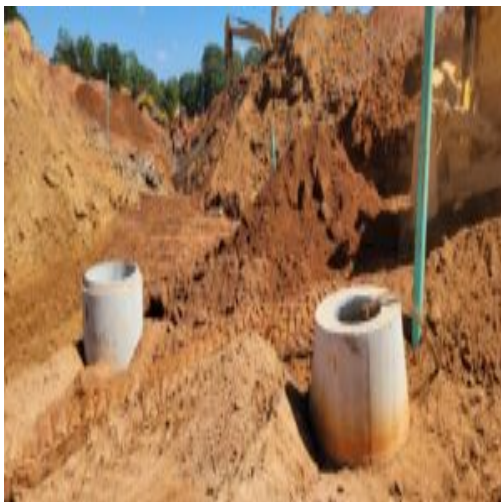
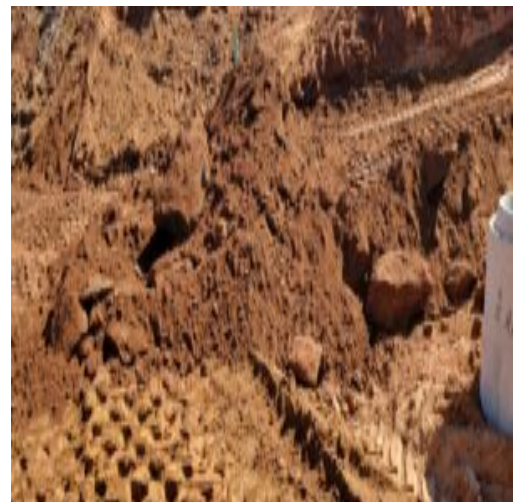
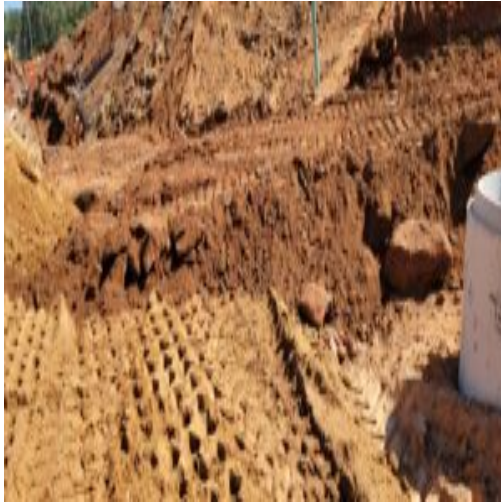
- The placement and compaction of backfill soils for Lots #35, 36, 37, 38, and Sower trench between MHC7 and MH C8, continued this day.
- At the time of arrival, our representative observed that work was in progress with one (1) foot lifts being placed at finished grade and compacted using trench and 15-ton compaction equipment. and observed work was on progress with (2) feet lifts being placed for the sewer trench in this day, see attached photos.
- Density test results indicate that the compacted materials met the project requirement of 90% of the maximum dry density obtained by the (Standard Proctor ASTM 698),
