Date : 09/28/2023  
Project No : 2023C144  
Client Company : CCG  
Arrival Time : 09/28/2023 8:00  
Onsite Hours : 08:00

ASEC Report ID : 62095  
Name of the Project : Carodel Farms @ Union Church Rd  
Project Location : Flowery Branch  
Weather : sunny  
Departure Time : 09/28/2023 16:00  
ASEC Technician Name : Aminullah Azimi

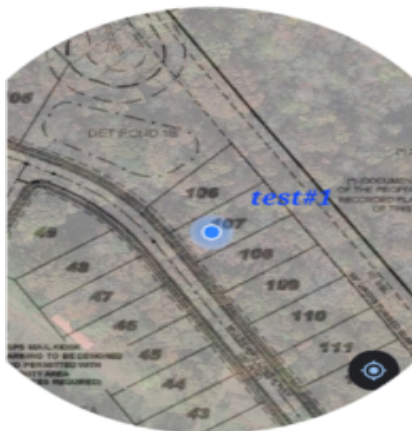
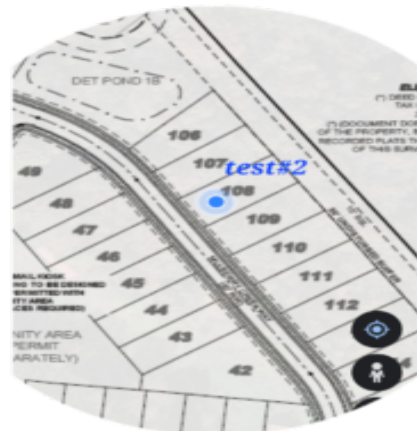
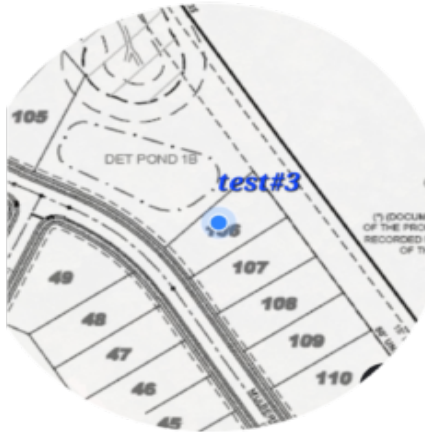
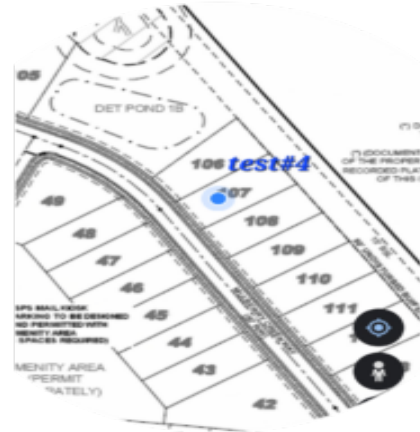
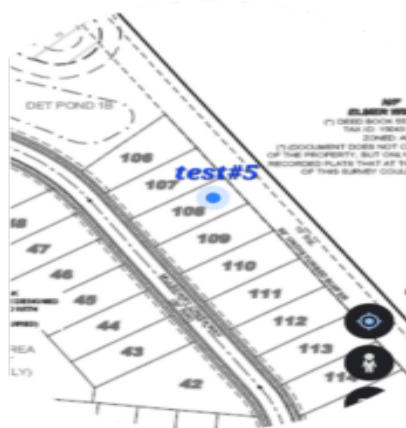
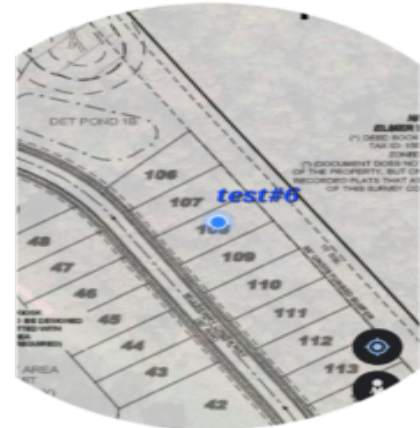
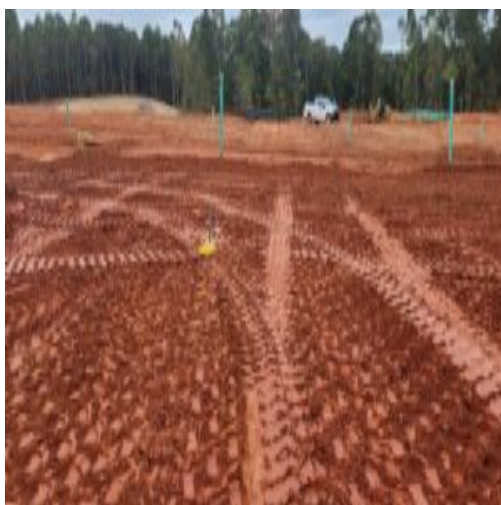
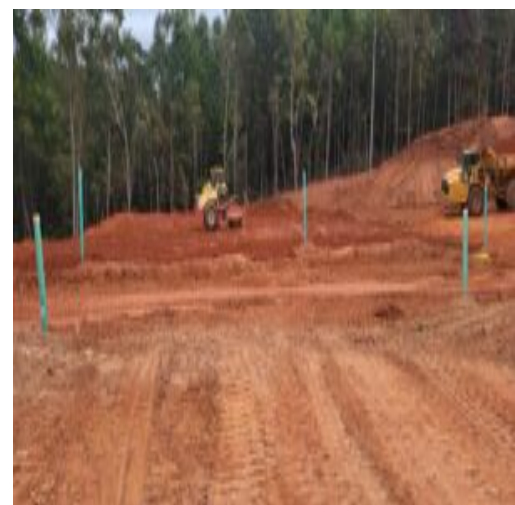
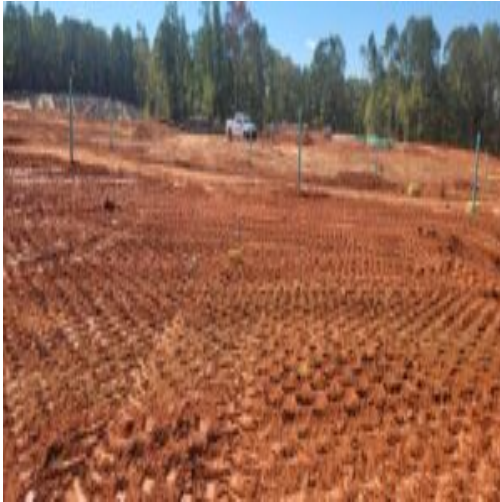
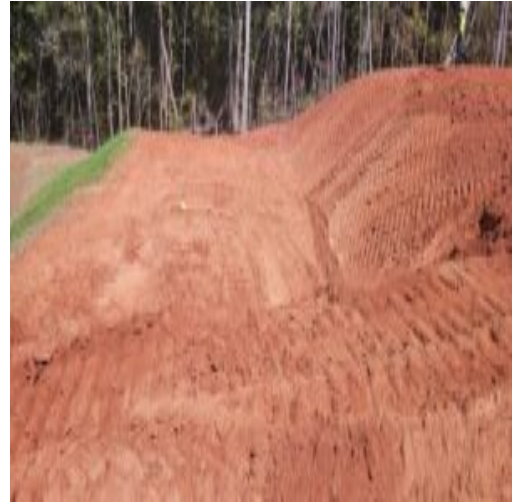
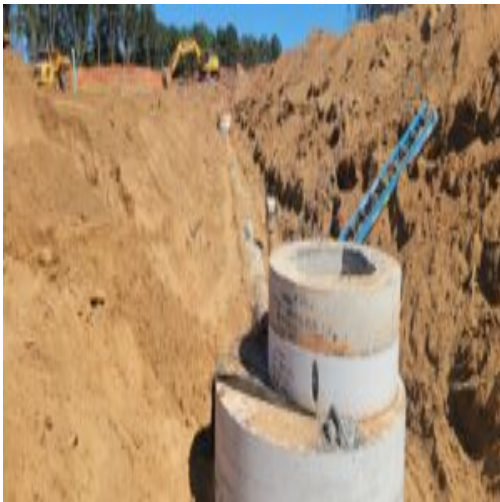
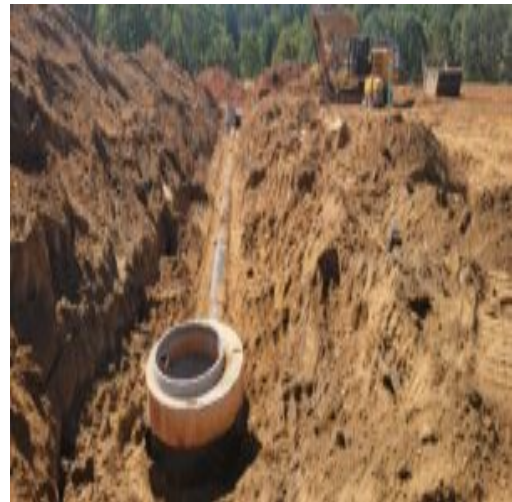
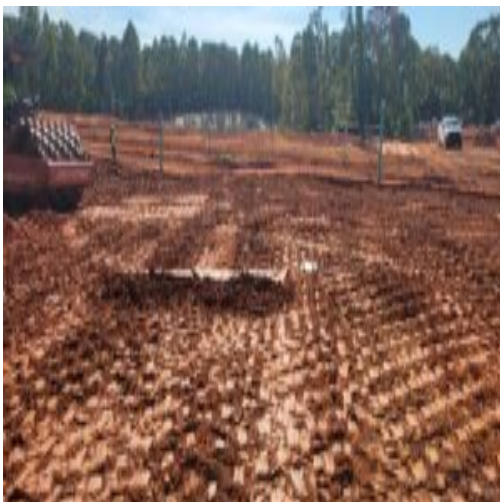
- The placement and compaction of backfill soils for Lots #106, 107 and 108 and placement of water storm pipe between MH 70 and MH 71, continued this day.
- At the time of arrival, our representative observed that work was in progress with one (1) foot lifts being placed at finished grade and compacted using 15-ton compaction equipment.
- Density test results indicate that the compacted materials met the project requirement of 90% of the maximum dry density obtained by the (Standard Proctor ASTM 698),
