Date : 10/31/2023  
Project No : 2023C144  
Client Company : CCG  
Arrival Time : 10/31/2023 8:30  
Onsite Hours : 04:00

ASEC Report ID : 62795  
Name of the Project : Carodel Farms @ Union Church Rd  
Project Location : Flowery Branch  
Weather : sunny  
Departure Time : 10/31/2023 12:30  
ASEC Technician Name : Aminullah Azimi

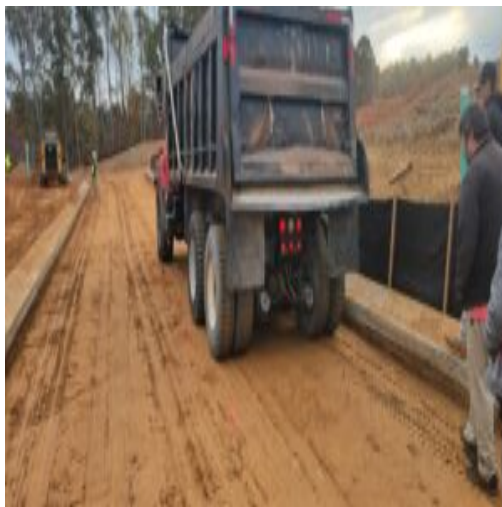
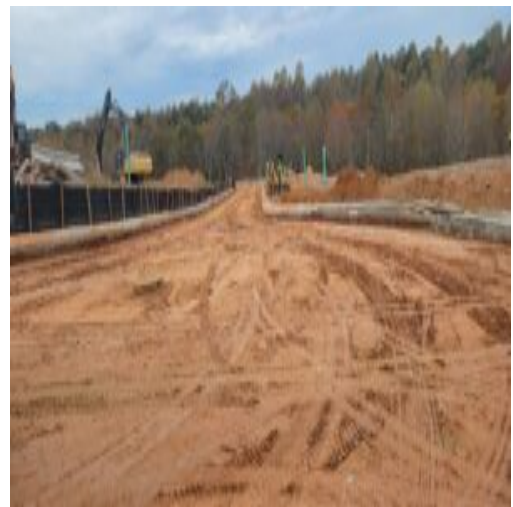
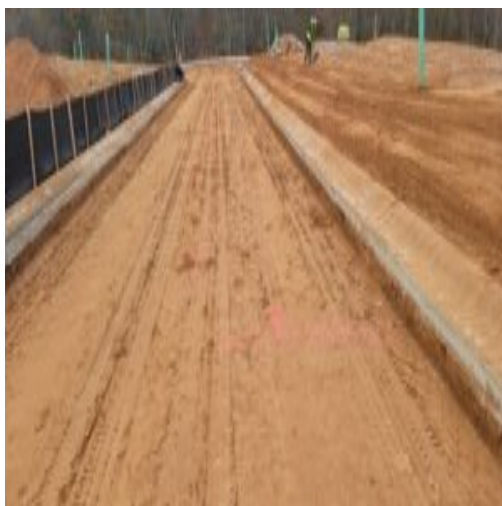
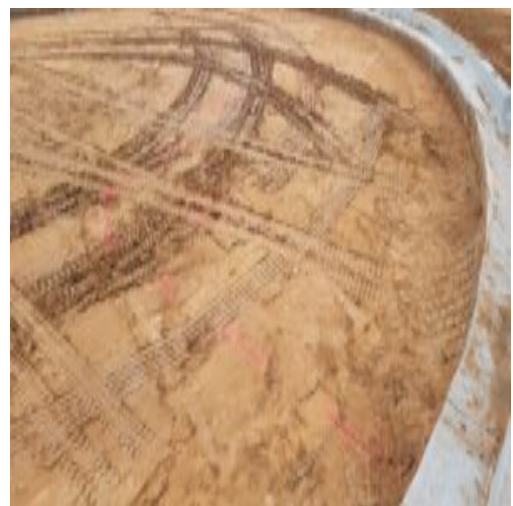
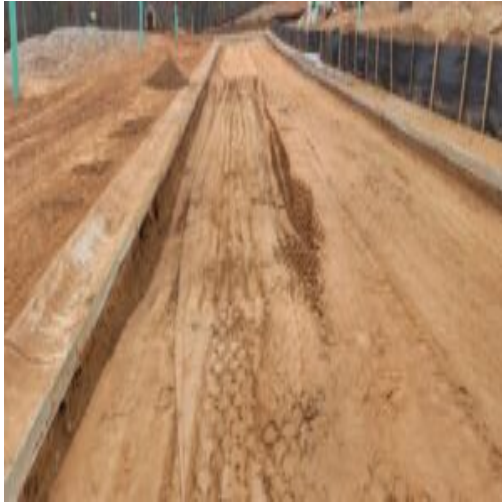
- A proof-roll observation was performed on the roadway in the front of Lots #86 to 93,
- A fully loaded tandem-axle dump truck was used to proof-roll the above-mentioned subgrade with multiple passes across the area.
- No severe yielding or deflection was observed during the proof-roll at all areas mentioned above with the exception of two soft areas (10'x40') in the front of Lot #89 and (12'x20') in the front of Lot # 85. It was recommended to remove the soft soils to a depth of 6" and replaced with GAB and compact the area.
