ASEC Report ID : 61822  
Name of the Project : Lakeside  
Project Location : Calhoun  
Weather : Sunny  
Departure Time : 09/20/2023 13:00  
ASEC Technician Name : Vidal Dias

The undersigned ASEC representative was on-site on September 20, 2023, to observe excavation of five test pits just north of the pond to evaluate a berm for potential in-situ soils that could be re-used as structural fill material. The objective was to assess the soil conditions and provide engineering recommendations for the cut depths required to reach grade.

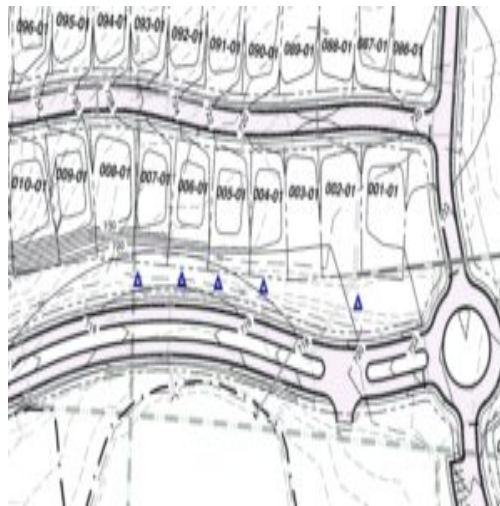
- Test Pit 1: 4-foot cut to grade
- Test Pit 2: 4-foot cut to grade
- Test Pit 3: 5-foot cut
- Test Pit 4: 6-foot cut
- Test Pit 5: 8-foot cut
