Date : 10/25/2023  
Project No : 2023C180  
Client Company : Artisan Communities  
Arrival Time : 10/25/2023 08:00  
Onsite Hours : 04:00

ASEC Report ID : 62750  
Name of the Project : Lakeside  
Project Location : Calhoun  
Weather : Sunny  
Departure Time : 10/25/2023 12:00  
ASEC Technician Name : Vidal Dias

## Soil Evaluation for Lots #96, 97, and Parking Lot Area

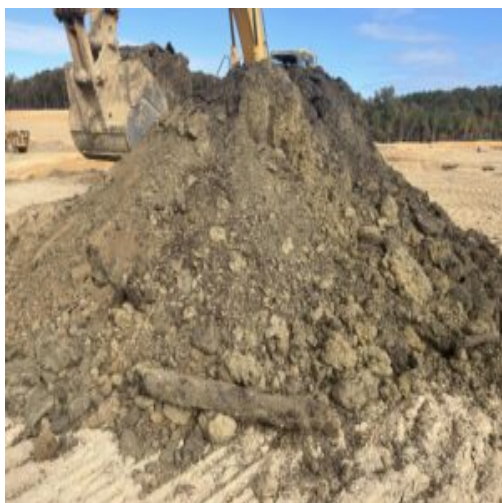
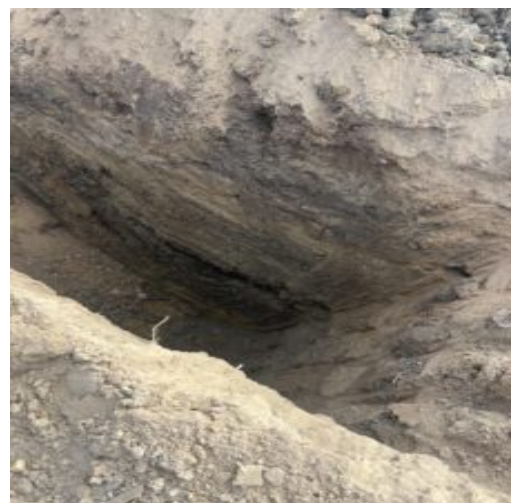
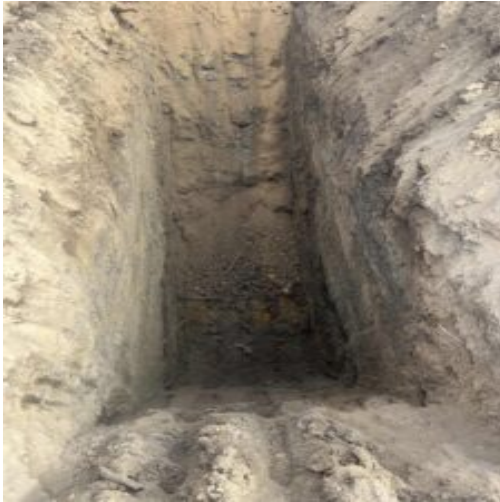
- Topsoil mixed with organic materials and roots.

- Three test pits were performed to evaluate the extent of the topsoil layer.
- The approximate volume of material removed from the area was 64,500 cubic feet.
- Given the presence of organic materials and roots, it is recommended that these soils be further assessed for suitability as fill material or be removed.
