ASEC Report ID : 62987  
Name of the Project : Lakeside  
Project Location : Calhoun  
Weather : Sunny  
Departure Time : 11/15/2023 12:00  
ASEC Technician Name : Vidal Dias

On November 15, 2023, the undersigned ASEC representative visited the Lakeside Development site. The purpose of the visit was to inspect the undercutting of topsoil materials in Lots #68, 69, 70, and 71, and to evaluate surficial soils adjacent to Lots #34 through 37, which were in question by the contractor.

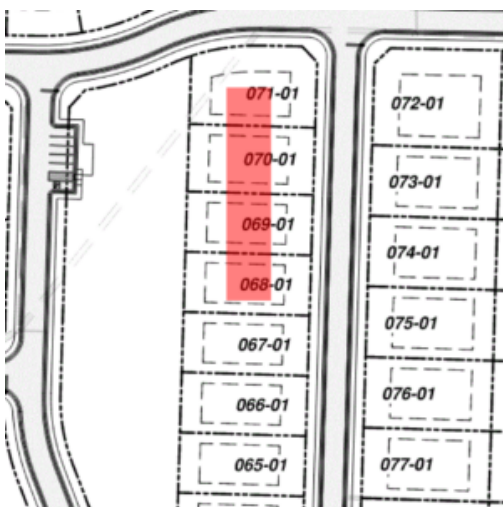
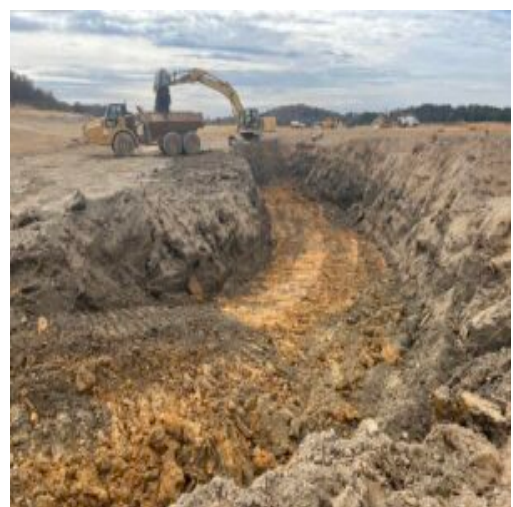
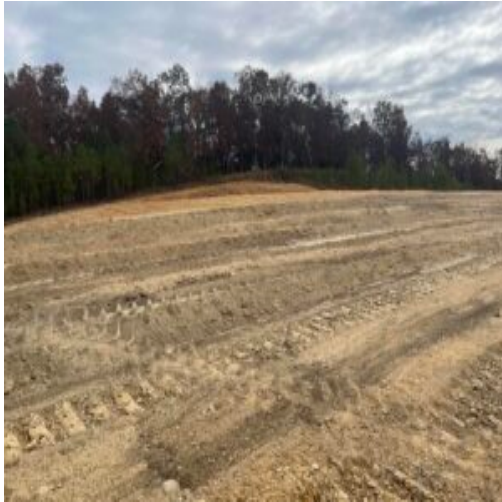
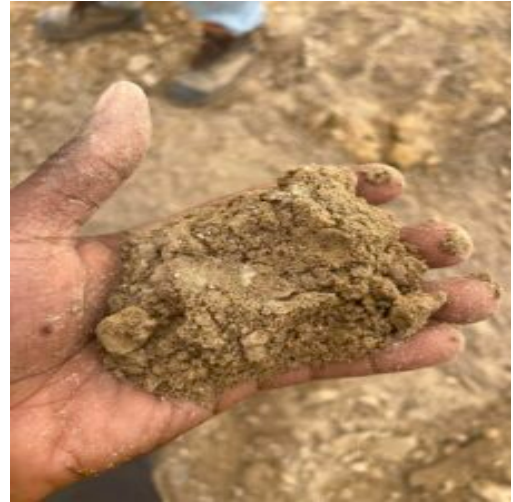
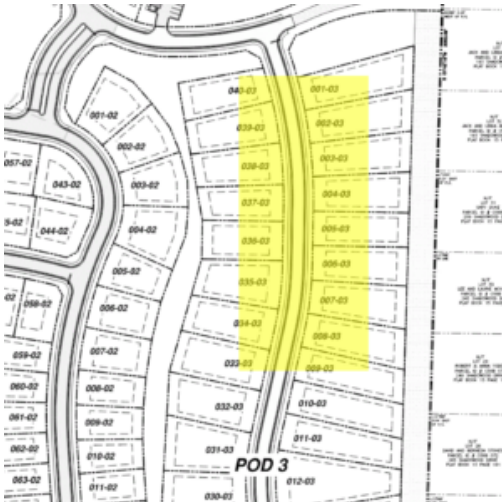
- The topsoil material depths in these lots were visually inspected quantity.
- The undercutting areas are shown in red on the attached drawing.

- The soils in this area were observed to be tan to brown, Silty fine to medium, and Sand.

- Large boulders were excavated from the road in the area highlighted in yellow on the attached drawing.
