Date : 03/29/2024  
Project No : 2023C180  
Client Company : Artisan Communities  
Arrival Time : 03/29/2024  
Onsite Hours :

ASEC Report ID : 65779  
Name of the Project : Lakeside Sub., Calhoun  
Project Location : Calhoun  
Weather : overcast  
Departure Time : 03/29/2024  
ASEC Technician Name : Russell Hendrix

**Location:** Section from 4.4 to 4.5

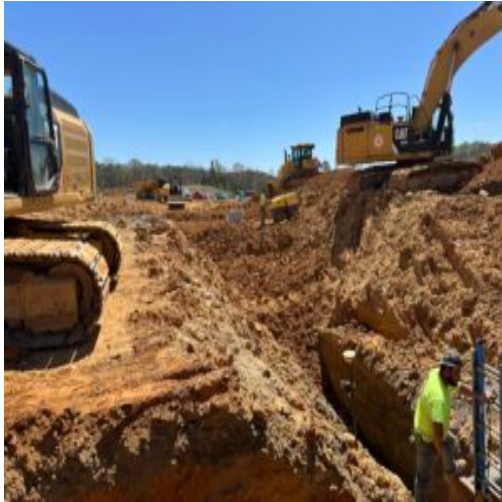
sanitation sewer facing 4.4

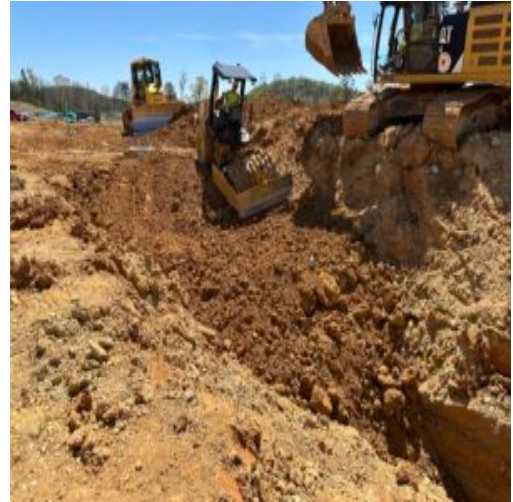
- Trench packer and riding vibratory sheepsfoot were employed for compaction.
- A recommendation of 6-inch lifts for compaction using the trench packer and 12 inches with a ride-on vibratory roller was provided to the foreman but not followed.

compacting sanitation sewer at 4.4

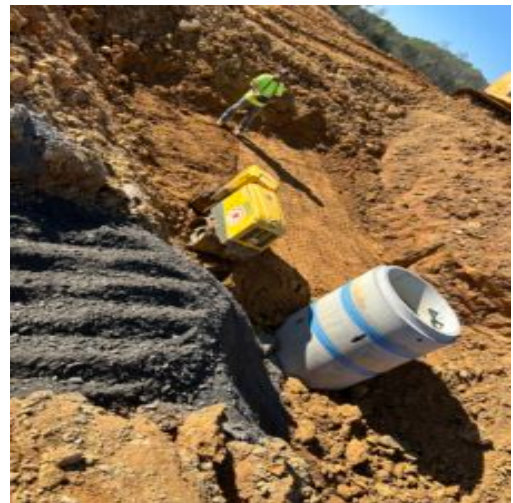
- For the lateral northeast of 4.4 (086-02), 6 inches of 57 stone was utilized for bedding, while graded aggregate base (GAB) was used for the remainder beneath the future road.
- Lift depths varied, with approximately 2 to 3-foot depths for the lateral and 4 to 5-foot lifts for the main line between 4.4 and 4.5.

4.4 with Lateral (GAB)

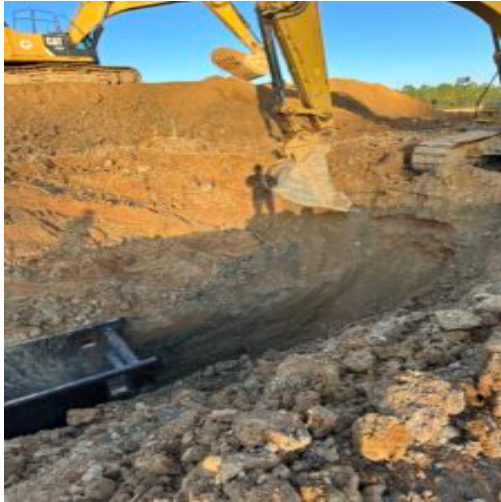
4.5 location (not set)
