Date : 11/29/2023  
Project No : 2023C201  
Client Company : Artisan Built Communities  
Arrival Time : 11/29/2023 08:00  
Onsite Hours : 04:00

ASEC Report ID : 63153  
Name of the Project : Jasons Walk - Era Drive  
Project Location : Era Drive, Cumming, GA  
Weather : Partly Cloudy  
Departure Time : 11/29/2023 12:00  
ASEC Technician Name : Vidal Dias

## Daily Field Report

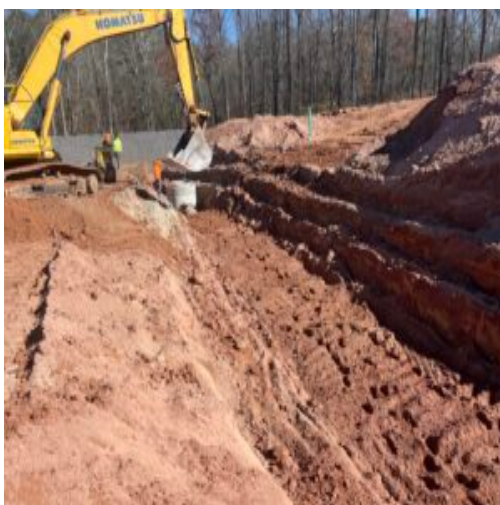
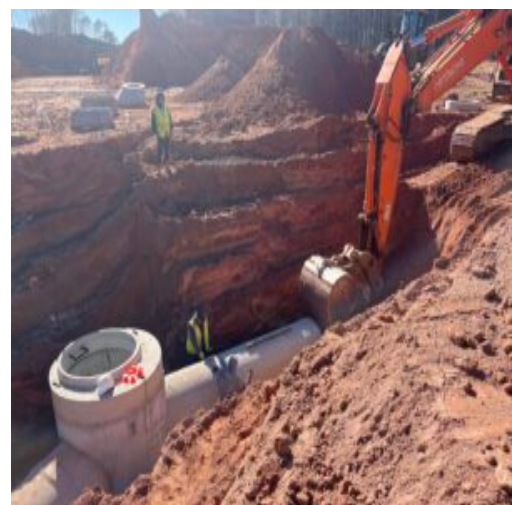
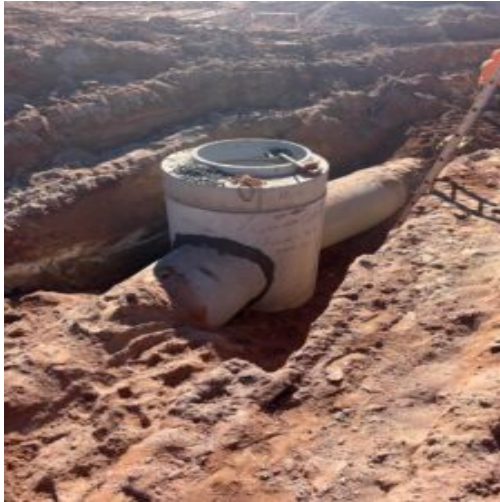
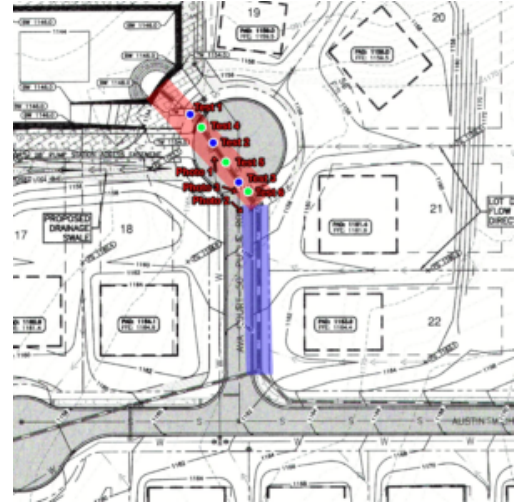
- **Activity Observed:** Backfill of the trench for storm drain installation.
- **Method:** The contractor backfilled the trench in 6 to 8-inch lifts.
- **Compaction Tests:** Six compaction tests were performed to ensure compliance with project specifications.
- **Location:** The area of backfill is shown in red on the attached site drawing.

- **Location:** Stretching from Ava Court towards the intersection with Austin Michael Lane.
- **Activity Observed:** Excavation and laying of new storm pipe sections.
- **Method:** The contractor coordinated excavation and pipe laying operations.
- **Location:** The area where the new pipe was being placed is shown in blue on the attached site drawing.
- **Compliance:** All activities observed were in accordance with the project specifications and standards.
