Date : 12/29/2023  
Project No : 2023C201  
Client Company : Artisan Built Communities  
Arrival Time : 12/29/2023 08:00  
Onsite Hours : 04:00

ASEC Report ID : 63570  
Name of the Project : Jasons Walk - Era Drive  
Project Location : Era Drive, Cumming, GA  
Weather :  
Departure Time : 12/29/2023 12:00  
ASEC Technician Name : Vidal Dias

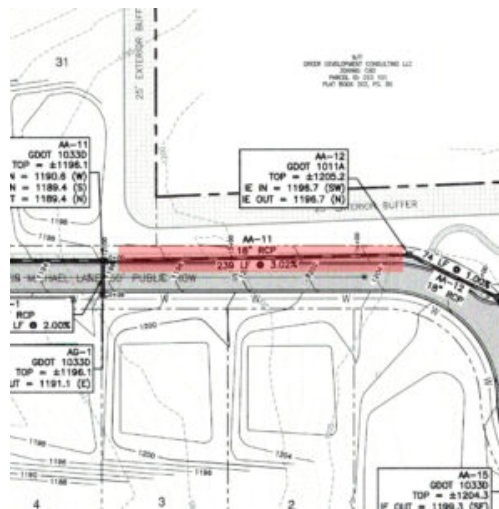
During this visit, a trash pit was discovered while placing the 18" pipe from AA11 to AA12. The area is highlighted in red on the attached drawing. The contractor has begun excavating the unsuitable soils from this area.
