Date : 05/22/2024  
Project No : 2024C112  
Client Company : SR Homes  
Arrival Time : 05/22/2024 10:00  
Onsite Hours : 07:00

ASEC Report ID : 66688  
Name of the Project : Sterlington  
Project Location : Canton  
Weather : sunny  
Departure Time : 05/22/2024 17:00  
ASEC Technician Name : Aminullah Azimi

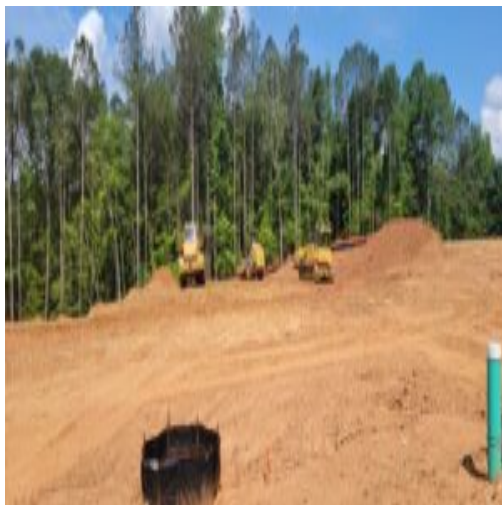
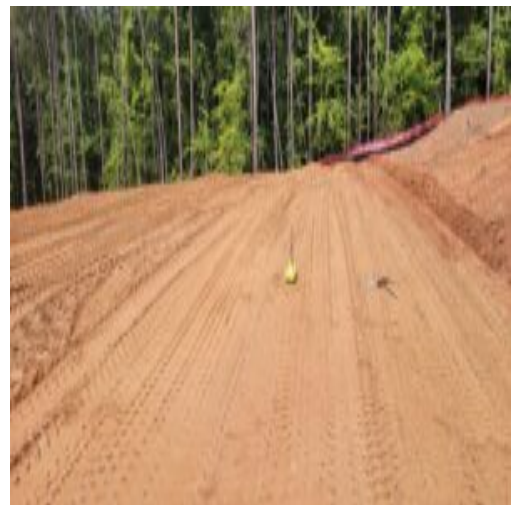
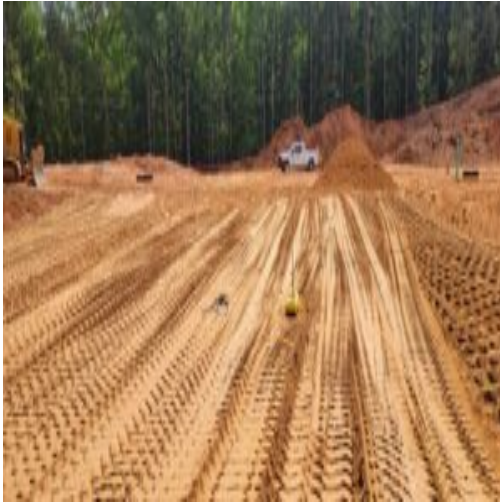
- The placement and compaction of fill soils for Lot #12, continued this day.
- At the time of arrival, our representative observed that work was in progress with 1-foot lifts being placed and compacted using trench and 15-ton sheeps-foot (CP54B) compaction equipment along with general probing using a 3/8" diameter probe rod.
- Density test results indicate that the compacted materials require scarification, aeration and recompaction prior to retesting.
