Date : 05/24/2024  
Project No : 2024C112  
Client Company : SR Homes  
Arrival Time : 05/24/2024 11:30  
Onsite Hours : 05:00

ASEC Report ID : 66726  
Name of the Project : Sterlington  
Project Location : Canton  
Weather : cloudy  
Departure Time : 05/24/2024 16:30  
ASEC Technician Name : Aminullah Azimi

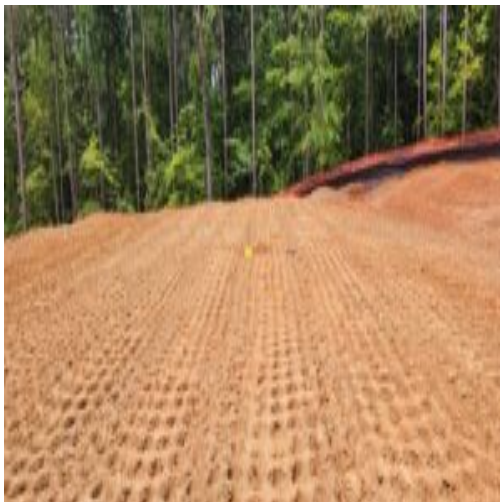
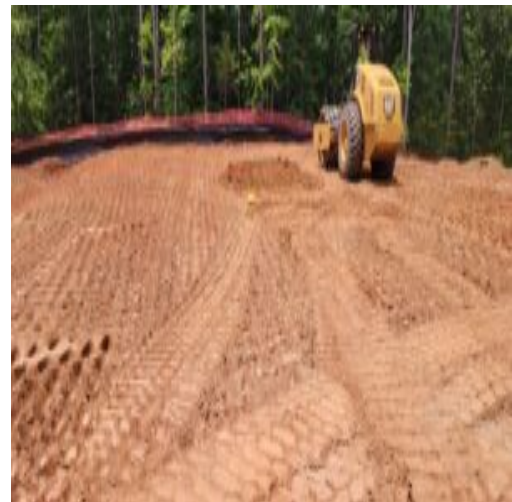
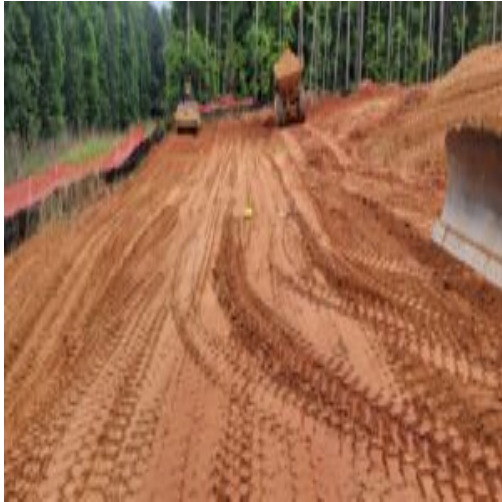
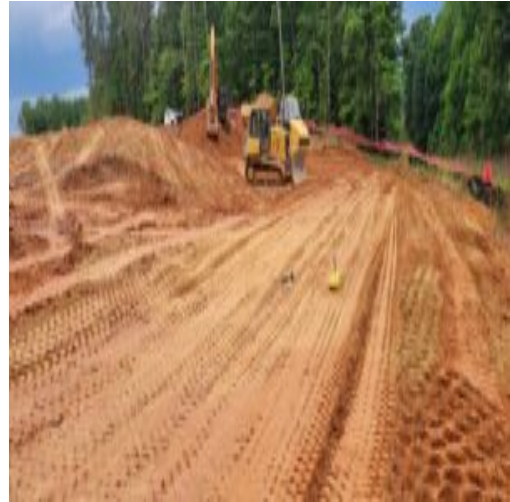
- The placement and compaction of fill soils for Lot #13, Lot #14 and basements of Lot #15 and Lot #16, continued this day.
- At the time of arrival, our representative observed that work was in progress with 1-foot lifts being placed and compacted using 15-ton sheeps-foot (CP54B) compaction equipment and compaction testing was performed using a Traxler nuclear gauge done by QC along with general probing using a 3/8" diameter probe rod.
- Density test results indicate that the compacted materials did not meet the project requirement of 95% of the maximum dry density obtained by a Standard Proctor ASTM 698.
