Date : 07/12/2024  
Project No : 2024C112  
Client Company : SR Homes  
Arrival Time : 07/12/2024  
Onsite Hours :

ASEC Report ID : 67904  
Name of the Project : Sterlington  
Project Location : Canton  
Weather : sunny  
Departure Time : 07/12/2024  
ASEC Technician Name : Russell Hendrix

### Proof-Roll Inspection Report

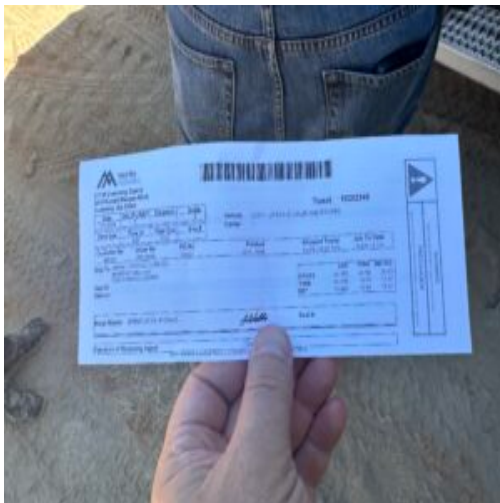
GAB delivery ticket with weight

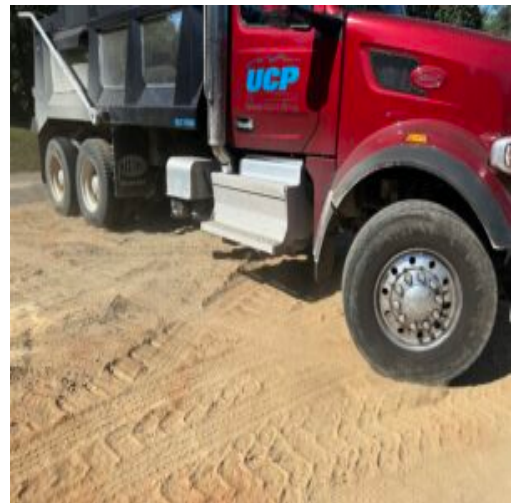
A proof-roll was performed using a loaded tandem-axled dump truck across the compacted soils along both sides of the future roadway (see attached photo). The county inspector, client, and grading foreman were present for the inspection. No severe pumping and/or rutting was observed, and all parties were in agreement with the results.

Loaded Tandem Dump truck
