Date : 05/29/2024  
Project No : 2024C116  
Client Company : Peeples Owner, LLC  
Arrival Time : 05/29/2024  
Onsite Hours :

ASEC Report ID : 66849  
Name of the Project : Peeples Valley Rd, Overlook at Pettit  
Project Location : Cartersville  
Weather : sunny  
Departure Time : 06/29/2024  
ASEC Technician Name : Russell Hendrix

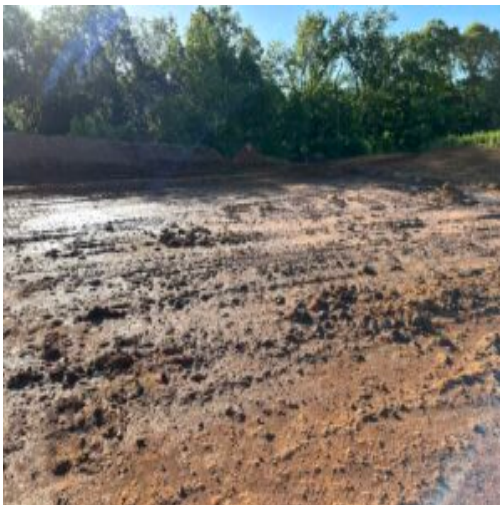
- **Owner/Developer:** Concerns were raised by the owner/developer regarding the high moisture area adjacent to the detention pond. Discussions ensued regarding potential remediation measures.
- **ASEC engineer, Ram Mogulla:** Contact was made with Mr. Mogulla regarding the remediation issue. He proposed alternative measures, including draining the detention pond, installing another burrito wrap, and utilizing a 2-foot bridge lift in the area.

Area adjacent to detention pond requiring remediation.

- **Consider Alternative Remediation Measures:** While soil cement was proposed by the owner/developer, alternative measures suggested by Mr. Mogulla may offer a higher chance of success. These include draining the detention pond, implementing an additional burrito wrap, and utilizing a 2-foot bridge lift.
- **Clarify Burrito Wrap:** There is ambiguity regarding the permanency of the burrito wrap. Further clarification is needed to determine whether it will be a temporary or permanent solution.

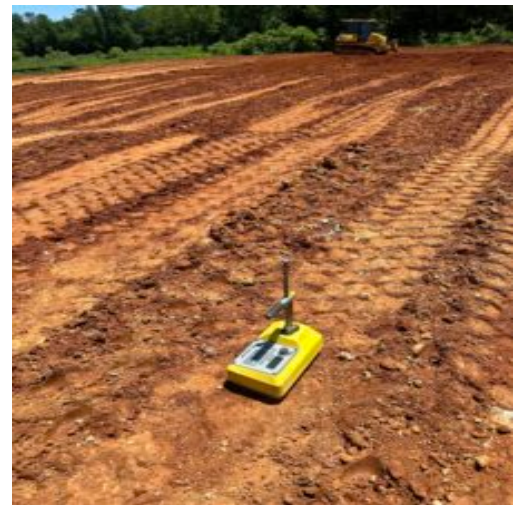
- **Compaction Testing:** Compaction testing was conducted using a Troxler 3430 with serial number 30942. Testing revealed acceptable compaction throughout the section, except for a specific area in the far north. (Compaction was completed with a ride-on vibratory sheeps-foot roller).
- **Proof Roll:** A proof roll was performed in the aforementioned problematic area (approximately 40 feet by 40 feet) using a loaded tandem off-road. This area failed due to significant pumping caused by high moisture contents in the underlying subgrade.
- **Remediation Efforts:** A request was made to the foreman for scarification and aeration of the identified area; however, remediation actions were not observed. An additional lift was conducted, excluding the failed area, which yielded acceptable results.

Testing section 1

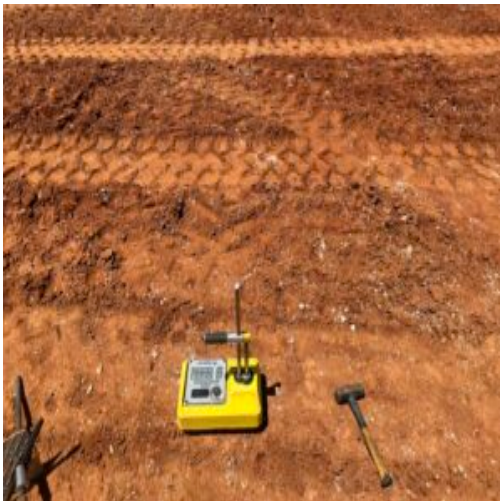
testing section 1

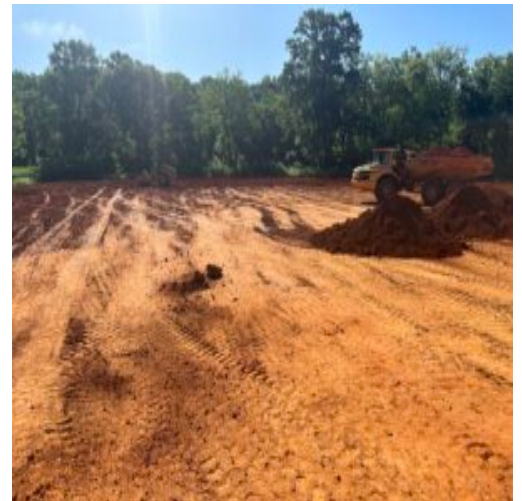
section 1 overview
