Date : 08/28/2025  
Project No : 2025C160  
Client Company : Artisan  
Arrival Time : 08/28/2025 08:30  
Onsite Hours : 06:00

ASEC Report ID : 84853  
Name of the Project : Rockmart Township - 115 Felton Drive  
Project Location : Rockmart  
Weather : Sunny  
Departure Time : 08/28/2025 14:30  
ASEC Technician Name : Sean Willett

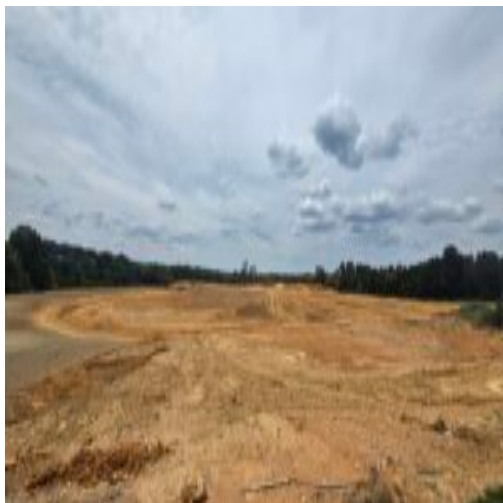
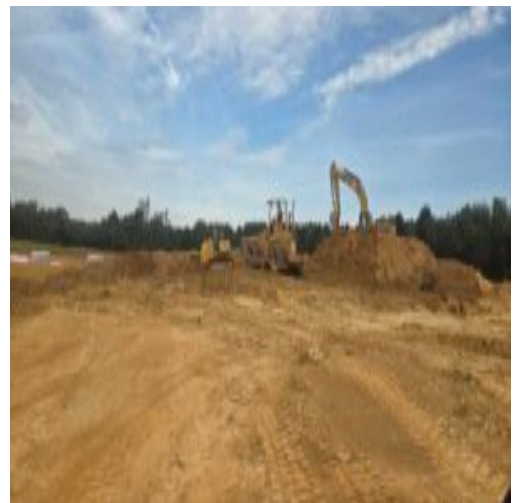
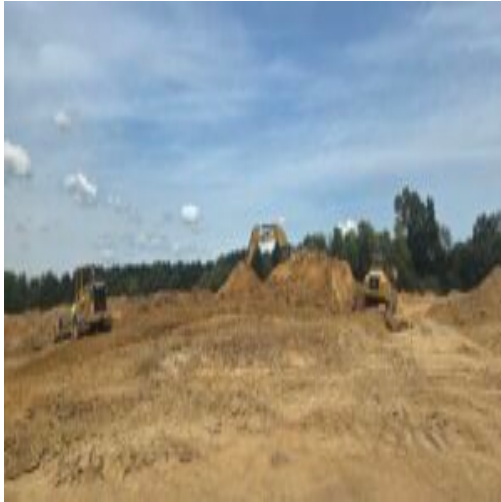
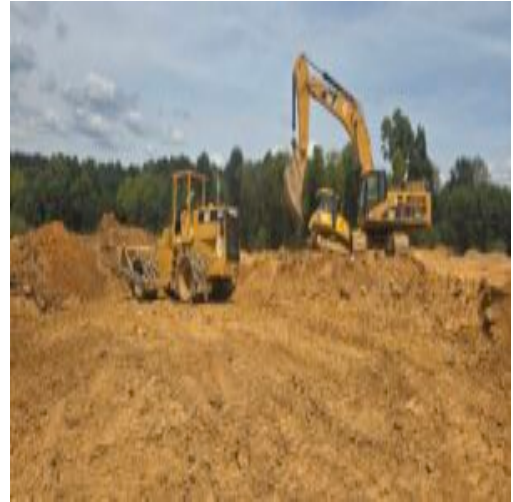
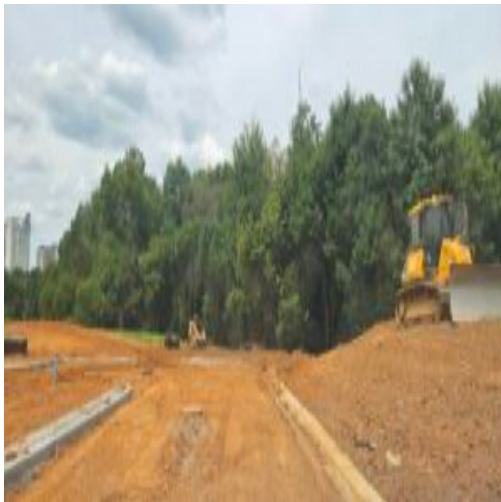
Our ASEC representative was on site as requested by the contractor (Wilbanks) for the observation/testing of the placement of fill/backfill. Our ASEC representative observed the contractor placing soil lifts of approx. 8in to 12in in thickness across Lot #157. The lifts were compacted with a sheep-foot roller. Our representative performed density testing for Lot #157 and the final grade of Lots #197 through #208. Test results were provided to the contractor.

The contractor has been prepping roadways and backfilling curbs.
