Date : 11/10/2025  
Project No : 2025C214  
Client Company : Artisan  
Arrival Time : 11/10/2025  
Onsite Hours : N/A

ASEC Report ID : 87721  
Name of the Project : NW Unit 4 BRIDGE (Materials Testing)  
Project Location : Dallas  
Weather : sunny  
Departure Time : 11/10/2025  
ASEC Technician Name : Russell Hendrix

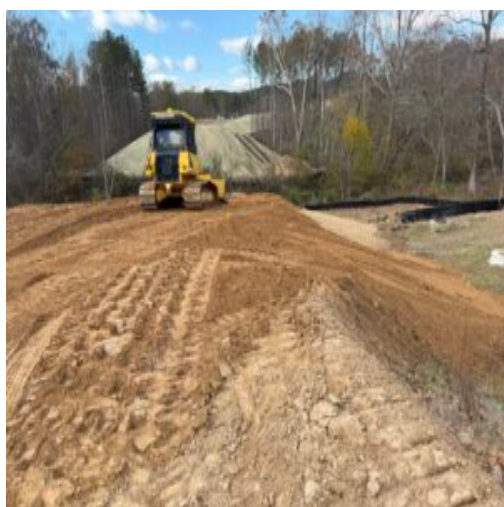
7 Hills BLVD side of future bridge

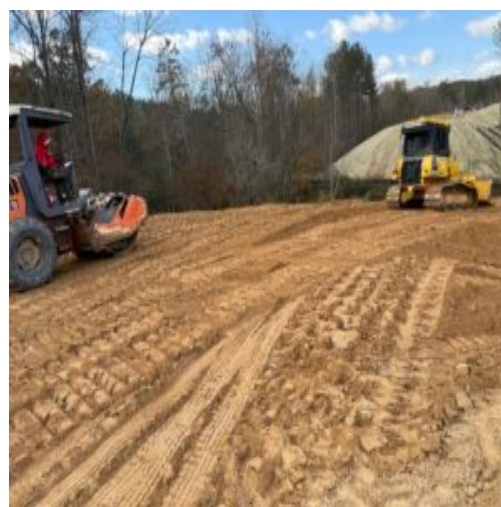
Work continued from the previous day involving the **importing and placement of brown silty sand** soil sourced from the **Seven Hills amenities area**. The soil was **spread by a Komatsu 39PXi dozer** and **compacted using a Hamm ride-on vibratory sheepfoot roller**.

Several lifts were placed during the observation period, with each lift measuring approximately **4-6 inches in thickness**. The placement area included the **future road alignment and adjacent slopes**.

The **foreman stated that this fill placement is temporary** and will remain in place until the **wing wall is fabricated**. Accordingly, **no field density or compaction testing was performed** at this time.

imported soil spread and compacted
