Date : 06/22/2026  
Project No : 2025C214  
Client Company : Artisan  
Arrival Time : 06/22/2026 08:00  
Onsite Hours : 05:30

ASEC Report ID : 95509  
Name of the Project : NW Unit 4 BRIDGE (Materials Testing)  
Project Location : Dallas  
Weather : Sunny  
Departure Time : 06/22/2026 13:30  
ASEC Technician Name : Sean Willett

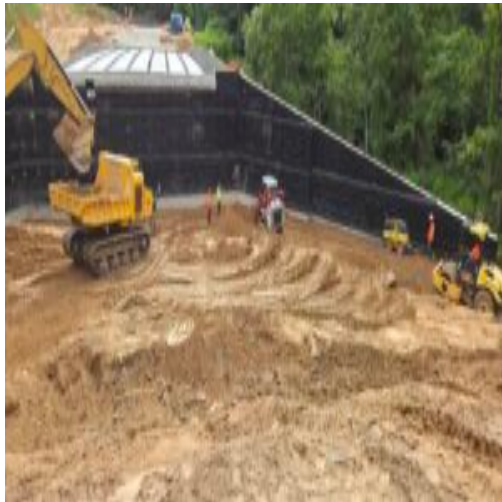
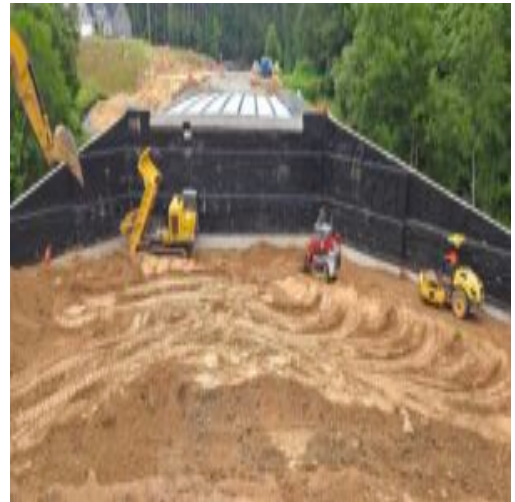
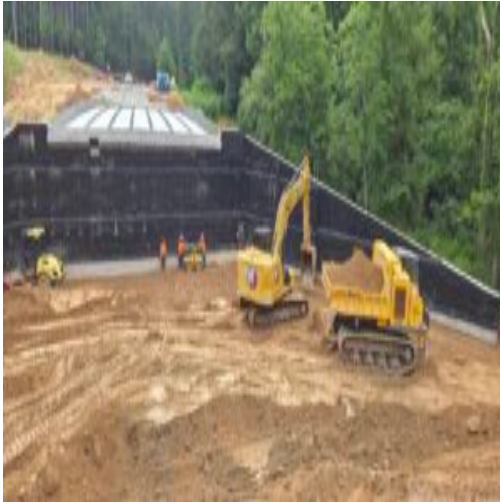
Our ASEC representative was on site to observe the contractor and for the observation/testing of the placement of fill/backfill. The contractors continued backfilling the bridge abutment. Soil lifts of approximately 8 to 12 inches in thickness were placed and compacted with a combination of a sheep-foot roller and a trench roller. Density testing was performed and test results were provided to the contractor. The contractor removed any large stones (greater than 1 foot in diameter) from the fill prior to compaction.
