Date : 09/15/2025  
Project No : 2025C215  
Client Company : Artisan  
Arrival Time : 09/15/2025 08:00  
Onsite Hours : 9:00

ASEC Report ID : 86385  
Name of the Project : NW Unit 4 Parkway Ext. Phase 1  
Project Location : Dallas  
Weather : Sunny  
Departure Time : 09/15/2025 17:00  
ASEC Technician Name : Austin Coleman

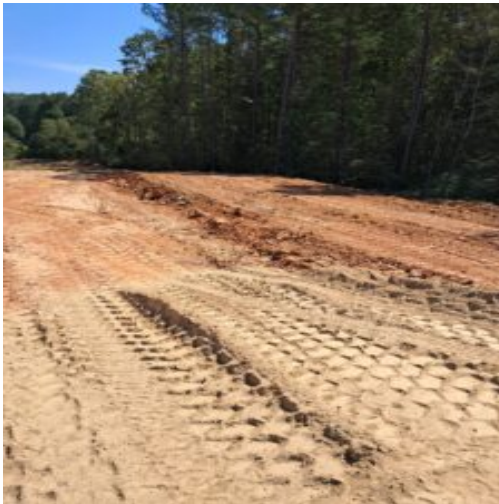
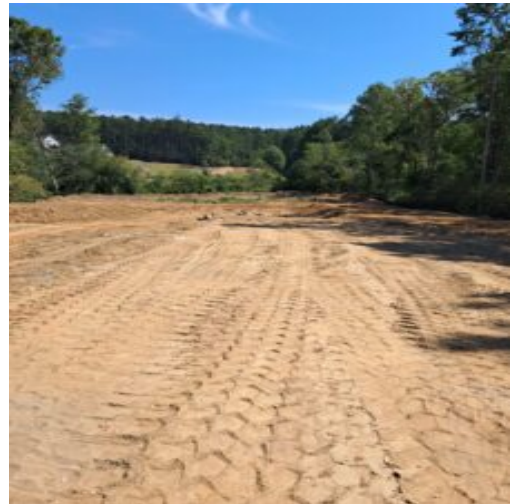
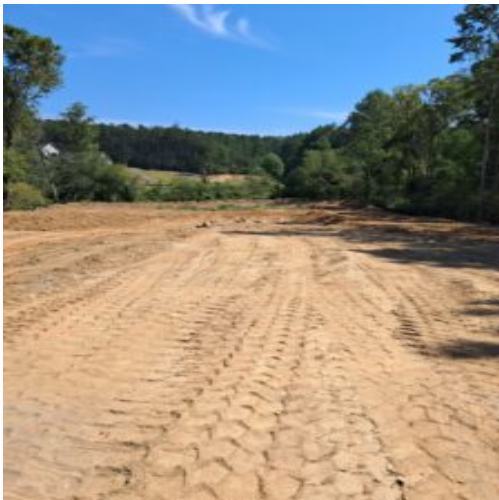
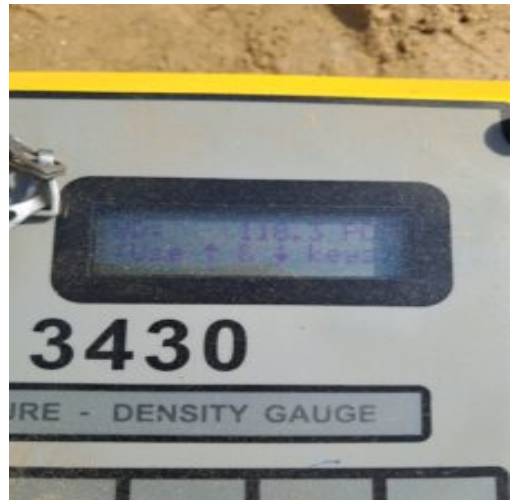
Our representative arrived on site and started with a check plug to check that the correct proctor was being used. Density testing using a nuclear gauge was then performed on the roadways near Manhole A5. Density test results met job specifications for compaction.
