Date : 11/04/2025  
Project No : 2025C260  
Client Company : Artisan  
Arrival Time : 11/04/2025 09:30  
Onsite Hours : 06:00

ASEC Report ID : 87495  
Name of the Project : NW (PHASE 2) Parkway Extension  
Project Location : Dallas  
Weather : Sunny  
Departure Time : 11/04/2025 15:30  
ASEC Technician Name : Clyde Smith

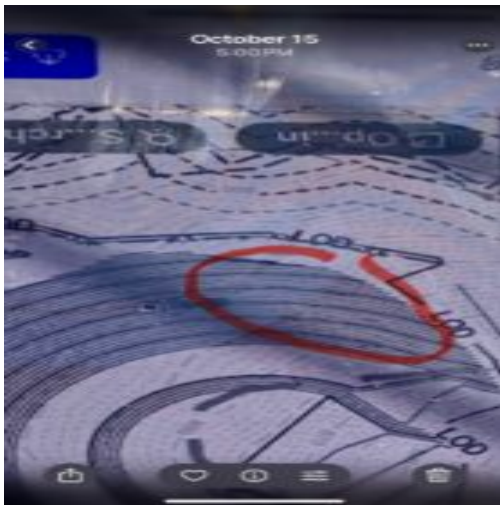
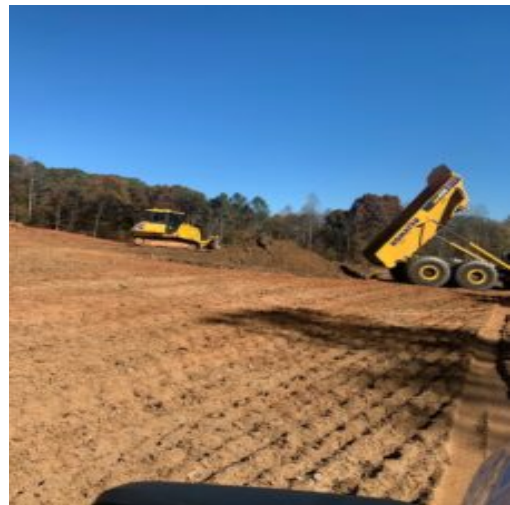
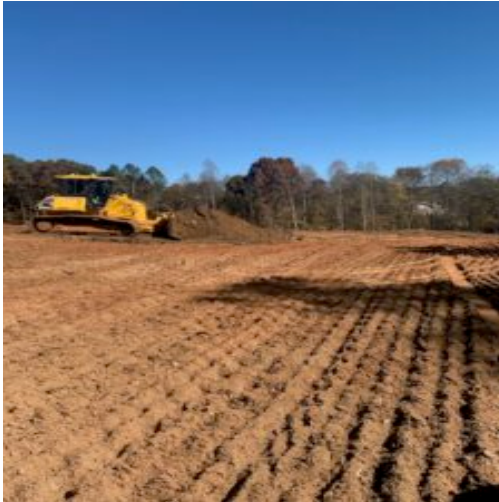
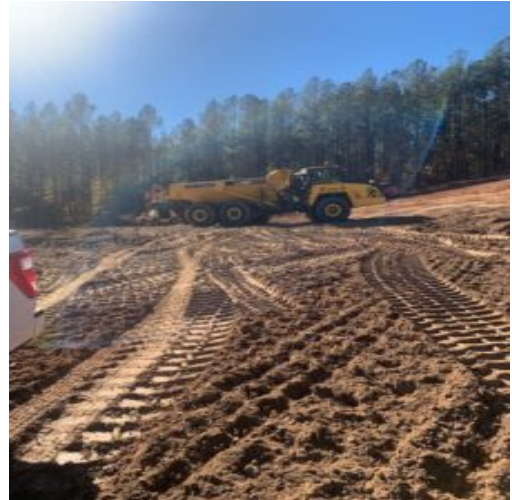
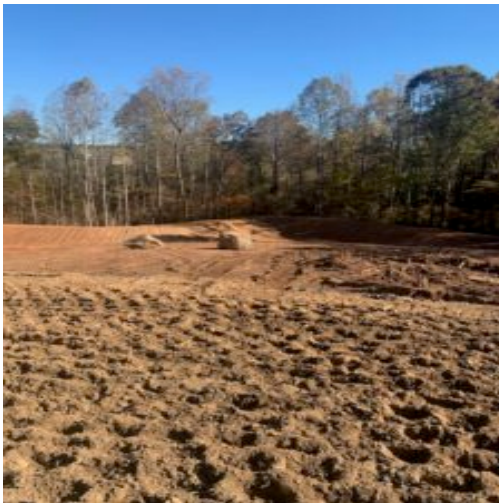
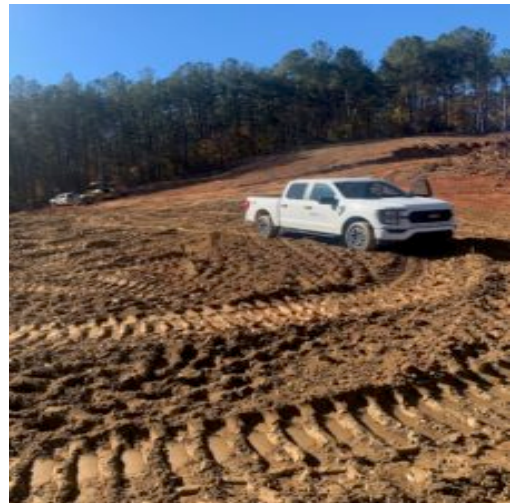
On the above date our representative from AS engineering and consultant was on site to observe the grading contractor continue placing rock fill for the slope embankment. The fill was placed in accordance with project plans and specifications for compaction requirements being observed by proof-rolling using an off- road loaded dump truck. The fill placement was observed from depths ranging from 32' to 28' below finished grade.

Slope embankment rock fill
