Date : 11/14/2025  
Project No : 2025C260  
Client Company : Artisan  
Arrival Time : 11/14/2025 15:00  
Onsite Hours : 01:00

ASEC Report ID : 87885  
Name of the Project : NW (PHASE 2) Parkway Extension  
Project Location : Dallas  
Weather : Sunny  
Departure Time : 11/14/2025 16:00  
ASEC Technician Name : Clyde Smith

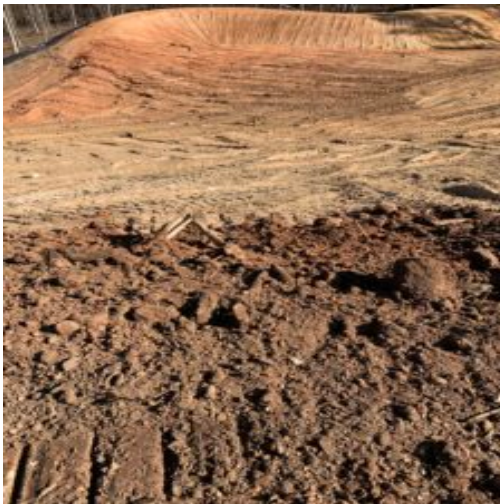
On the above date the writer made a site visit to observe placement of embankment slope fill using stripped topsoil from parkway mixed with structure fill at elevations 845, 836 and 829. The fill placement was suitable as per job plans and specifications. The fill was spread with a dozer and compacted with a 815 sheep-foot roller.

Fill placement at slope embankment ,topsoil and structural fill .
