Date : 05/22/2026  
Project No : 2026C142  
Client Company : KFE  
Arrival Time : 05/22/2026 08:30  
Onsite Hours : 02:00

ASEC Report ID : 94699  
Name of the Project : Bailey Station Way  
Project Location : Sharpsburg  
Weather : cloudy  
Departure Time : 05/22/2026 10:30  
ASEC Technician Name : Samara Simha Reddy Kandi

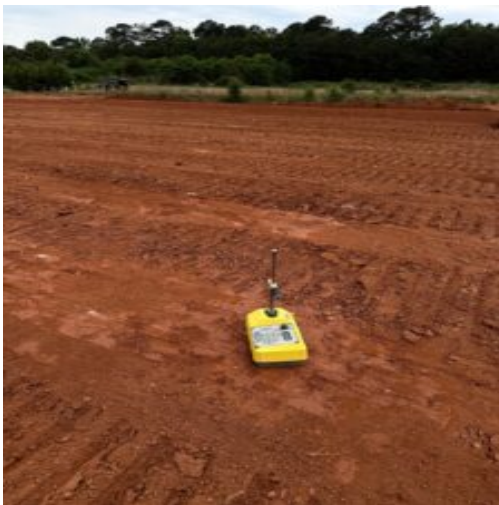
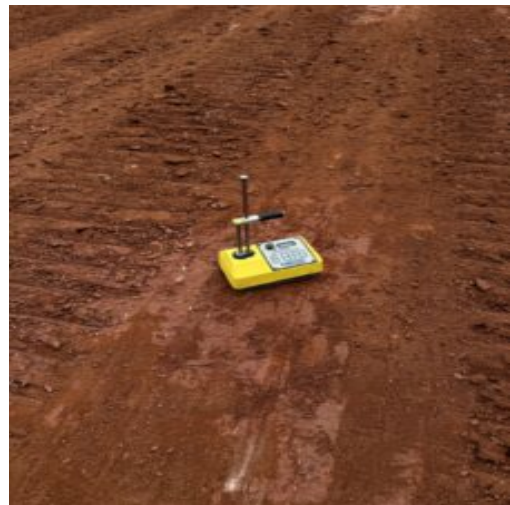
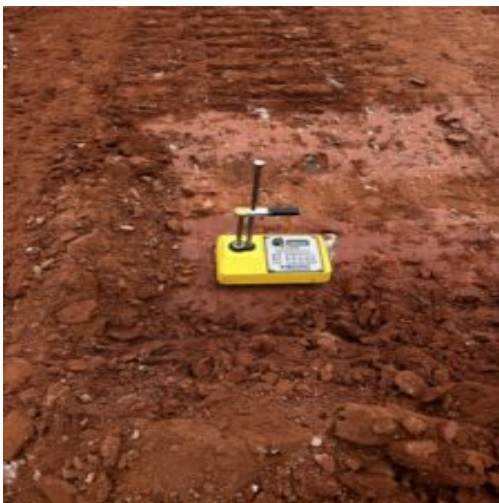
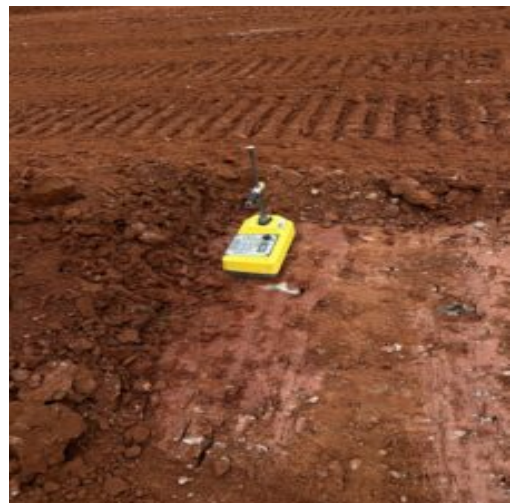
Contractor continued placing fill material for building pad Suite 3 and near Suite 1 using dump trucks. The material was spread along Suite 3 with the help of a crawler bulldozer to achieve the required grading. No compaction activities were performed in this area during the site visit because only one worker was present on site at the time. Density tests were performed in the Suite 1 area, which had been compacted on the previous working day, and the test results met the required compaction specifications.
