Date : 11/23/2020  
Project No : 2020C009  
Client Company : DR Horton  
Arrival Time : 11/23/2020 11:30  
Onsite Hours : 04:00

ASEC Report ID : 1323  
Name of the Project : Monet Gardens  
Project Location : River Road at Green Pastures Way,  
Ellenwood, GA  
Weather : Sunny  
Departure Time : 11/23/2020 15:30  
ASEC Technician Name : Dave Bek

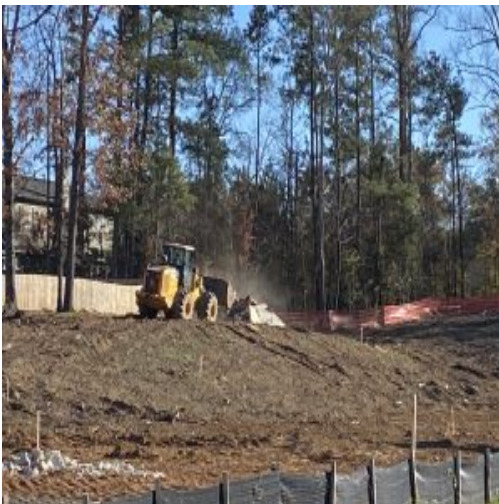
- On-site today @ 12:00 for general earthwork observation.
- Upon arrival I noted that a trench was being excavated in the area directly behind and in-between lot 19 and 18. The area cut was outside the area of the main building pad. The contractor explained that the area would be filled with the onsite concrete rubble from various parts of the development. Mainly the broken pieces of the concrete slab that was used as a basketball court.

Concrete rubble of former basketball court

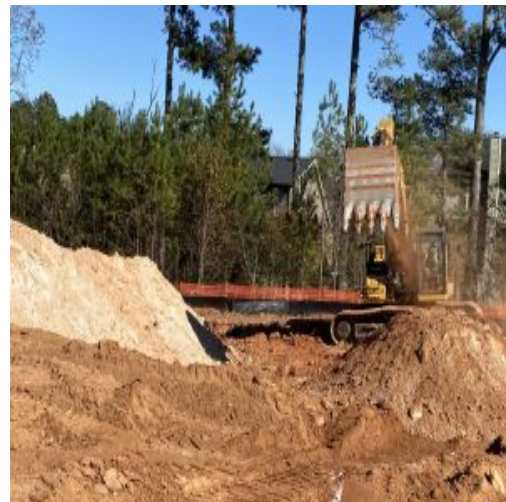
Trench area Lot 18 - 19 used for concrete rubble from various areas of site.

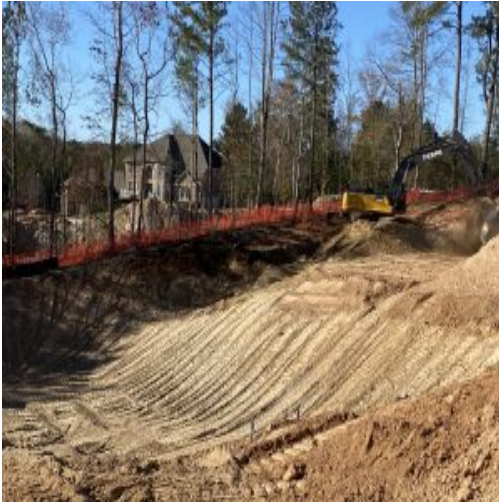
- General earthwork was also underway on the retention pond B in an area directly behind lot 7. The location is outside the area of the main building pad.

Area behind lot 7 (Not within building pad area)

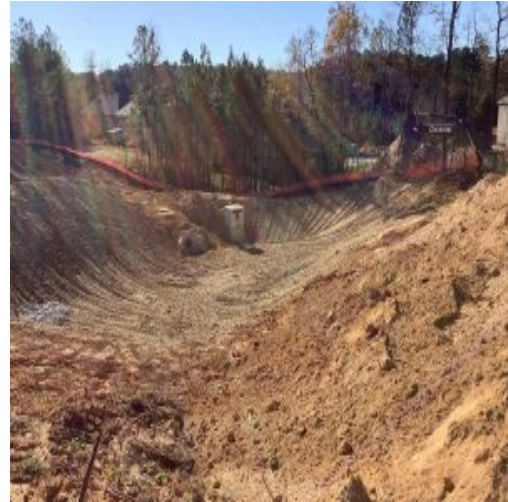
General earthwork on secondary retention pond.
