ASEC Report ID : 34258  
Name of the Project : Oakhurst Glen - Ph 4  
Project Location : Mallord Drive, South Fulton, GA  
Weather : Partly cloudy  
Departure Time : 09/23/2021 12:30  
ASEC Technician Name : Christopher Burrow II

As requested, a ASEC Inspector was present at the above referenced site for the purpose of observing the placement of structural fill at the area of lots 304 through 312 (area approximate size 25 feet by 350 feet). Based on review of guidelines for fill placement, the required compaction for structural fill at the above mentioned area was 95 % of standard proctor. Based on visual observation and field measuring, the fill was placed in 8 to 12 inch thick lifts and compacted using CAT 815F sheepsfoot compactor(weight; 45,757 lbs.). Based on density testing the fill placed today at depths between approximately -4 feet and -3 feet below finished grade was compacted according to fill placement guidelines. See attached density test results for more details.

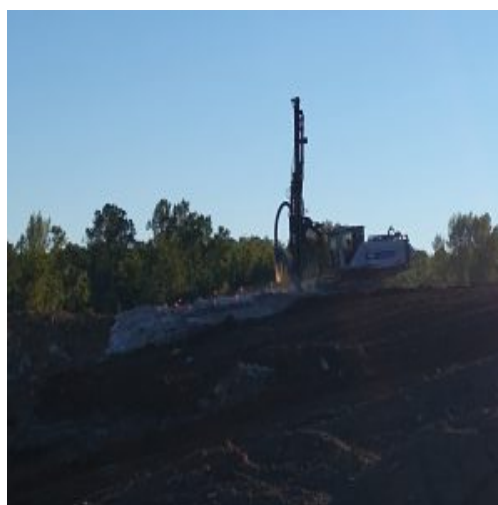
- Erosion control is being done on site.
- Drilling is being done on site by Precision Blasting.
- Structural fill is being mined from the slope on area of lots 337 through 356 approximately. This is being done to bring the area down to final grade.
- Rock breaking is being continued on site.

Drilling on site.
