Date : 04/09/2021  
Project No : 2020C002  
Client Company : Toll Bros. Inc.  
Arrival Time : 04/09/2021 09:00  
Onsite Hours : 9:00

ASEC Report ID : 8463  
Name of the Project : Northfields at Polo Fields  
Project Location : 4805 Pittman Road, Forsyth County, Georgia  
Weather : Cloudy  
Departure Time : 04/09/2021 18:00  
ASEC Technician Name : Andrew McCullough

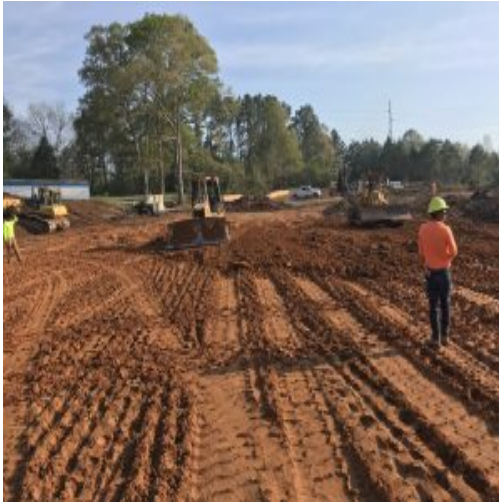
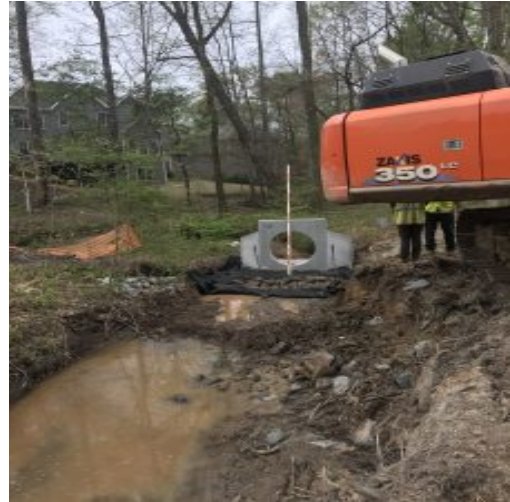
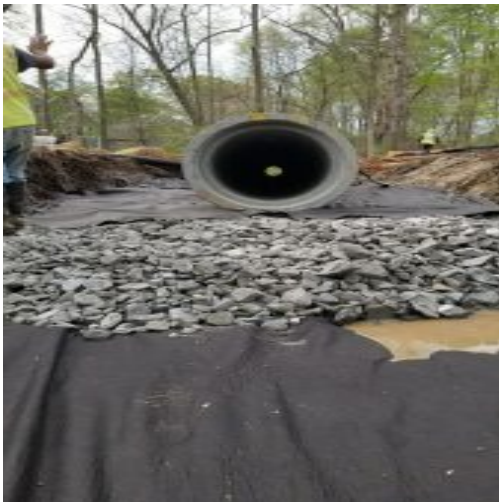
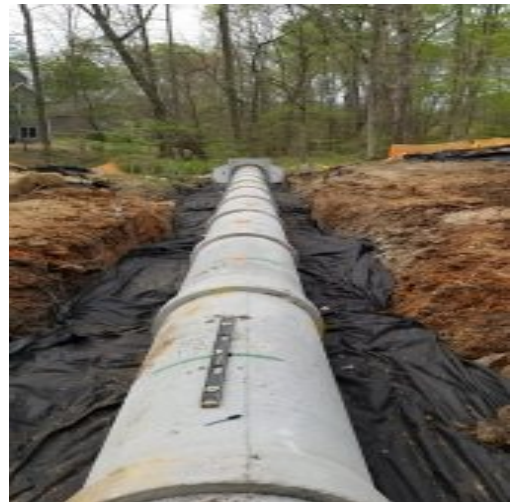
1. Upon arrival, the inspector visually observed the placement of soil at elevation 1087 within the vicinity of lots #4, #3 and #2. During compaction efforts, Visual signs of pumping and rutting were observed and the inspector ran a series of density test prior to the completion of the lift. The moisture content of the soil being placed was 30 % which exceeds the optimal moisture range of 22.2 plus or minus 3. The inspector informed the superintendent of the issue and he instructed this crew to finish the placement of this lift. An off-road truck was utilized to seal off this wet lift of soil in order to protect the fill that had already been placed from the upcoming rain event. Once the rain has passed and sunny days could be had, the lift at elevation 1087 will be tilled up and dried prior to the further placement of soil.

2. At lot #27 and #26, the inspector visually observed the installation of the RCP pipe at the creek crossing at HW E20 and HW E10. The recommendation from the project engineer was followed and all sections of pipe was installed accordingly. A total of 12" of #34 stone was installed at 8' wide for the first 59' of pipe installed, and a total of 18" of 34 stone was installed 8' wide for the remainder of 59' In order to achieve grade after the unsuitable soils had been removed. The pipe was installed according to the project engineers recommendation and back fill operations will continue the following week.

3. During the sealing of lots #4-#2, the backfill operation had been moved to lot #29 and #28. A proof roll with an off-road truck was performed in the area of lot #29 prior to the installation of soil. This area was firm and unyielding and is ready for fill. During this time, a natural gully spanning from the front center of lot #29 and ending at the center of lot #28 was being de-grubbed of top soil and being prepared for backfill. During this operation, a heavy layer of organic material was encountered followed by an extremely high water table inside of soft material. Random exploratory penetration resistance was performed inside of this area and no firm material was found between the organic layer and groundwater. After consulting with the project engineer Ram Mogulla, a recommendation of undercutting all organic material and installing a 2' soil bridge was given. The contractor proceeded to excavated the heavy layer of organic material at the inspectors discretion. Once the organic material was excavated, the inspector and the superintendent quantified the excavated material at 120'x5'x15'. A 2' un-compacted soil bridge was installed and the backfill efforts continued. The inspector observed the placement of structural fill across the soil bridge and based on review of guidelines for fill placement, the required compaction for structural fill at the above mentioned area is 95% of a standard proctor. Based on visual observation and field measuring, the fill was placed in 10-12" thick lifts and compacted using a sheep's foot. Based on density testing, the fill placed today at elevations approximately 1082-1085 was compacted according to project specifications. See attached density test results for more details.
