Date : 07/07/2026  
Project No : 2025C281  
Client Company : SR Homes  
Arrival Time : 07/07/2026 11:00  
Onsite Hours : 02:00

ASEC Report ID : 96131  
Name of the Project : Owen Mills - Owens Store Rd  
Project Location : Canton  
Weather : Sunny  
Departure Time : 07/07/2026 13:00  
ASEC Technician Name : Sean Willett

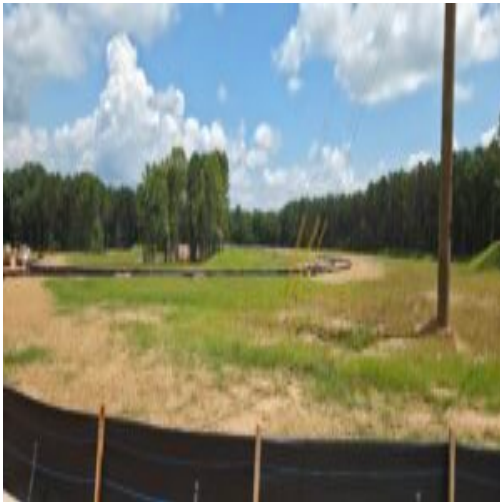
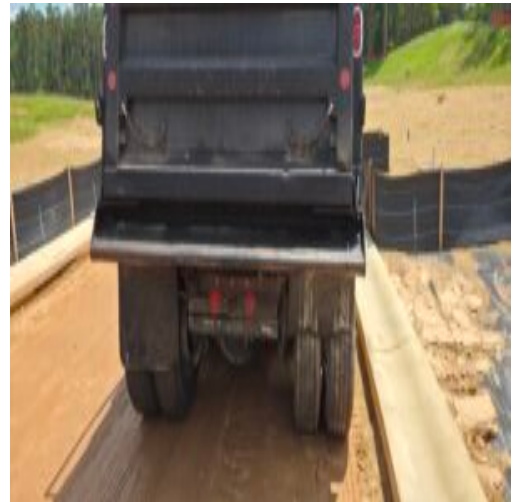
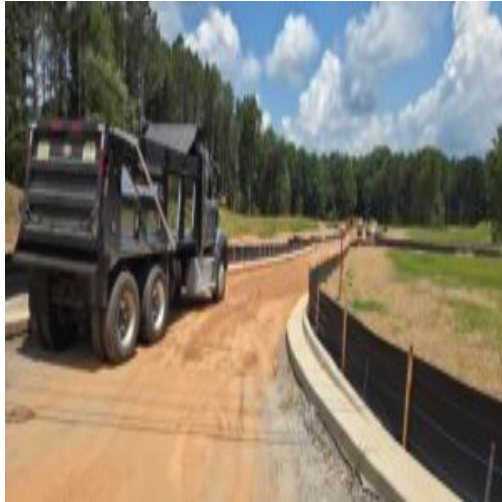
Our ASEC representative was on site as requested by the contractor for the observation/testing of the placement of fill/backfill. A proof roll was conducted on the roadways of the site. A loaded tandem truck was used to conduct the proof roll. There were no severe signs of pumping or cracking present. The contractor will be installing GAB over the next few workdays. The county requested density testing of the GAB approx. every 500ft, so a grab sample of GAB was taken to the lab for a proctor. We the contractors contact ASEC, we will be back onsite to proof roll the GAB and density test.
