Date : 06/25/2026  
Project No : 2026C136  
Client Company : RS Homes  
Arrival Time : 06/25/2026 08:00  
Onsite Hours : 07:00

ASEC Report ID : 95545  
Name of the Project : Collett Farms Storm Line & Pavement  
Project Location : Canton  
Weather : sunny  
Departure Time : 06/25/2026 15:00  
ASEC Technician Name : Samara Simha Reddy Kandi

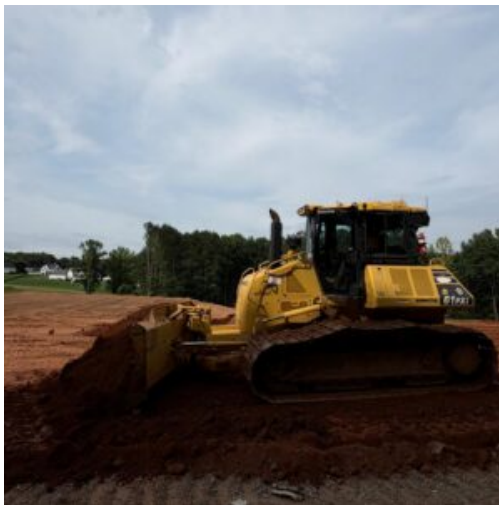
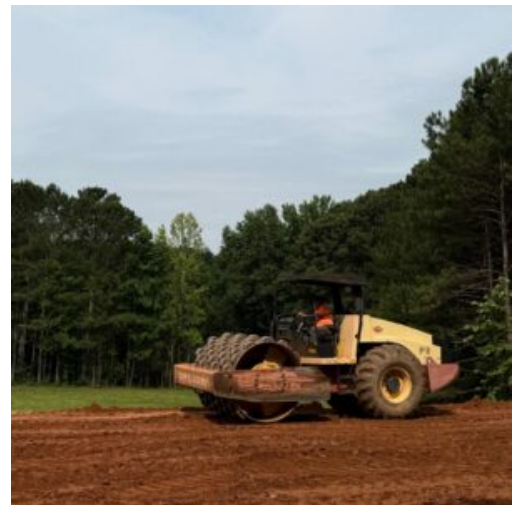
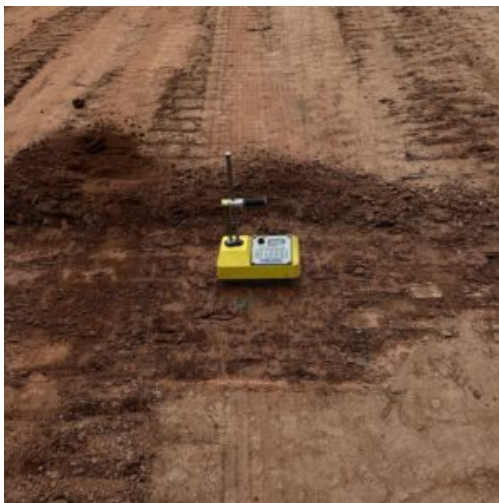
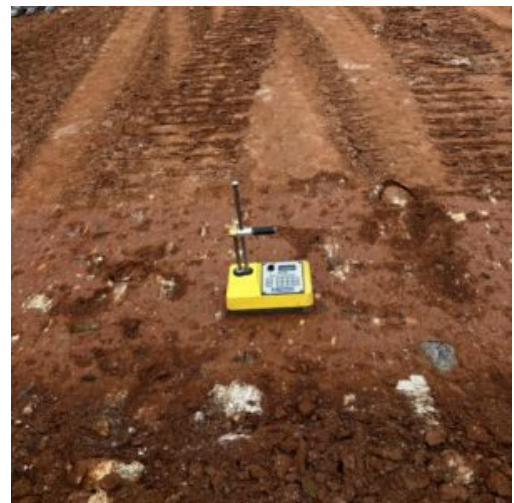
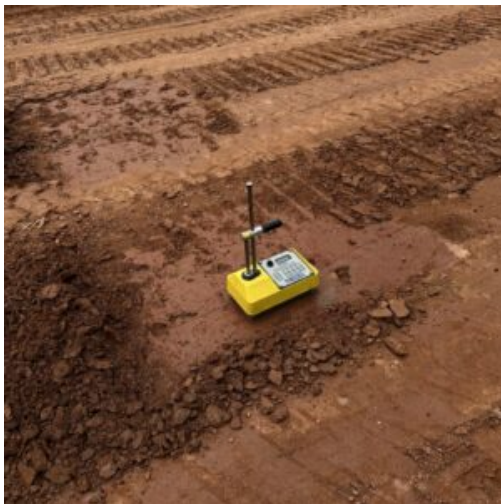
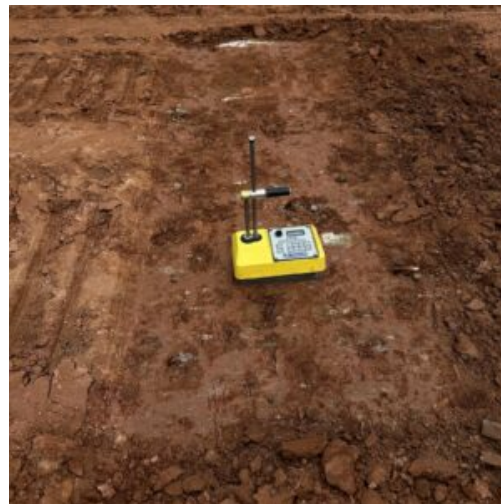
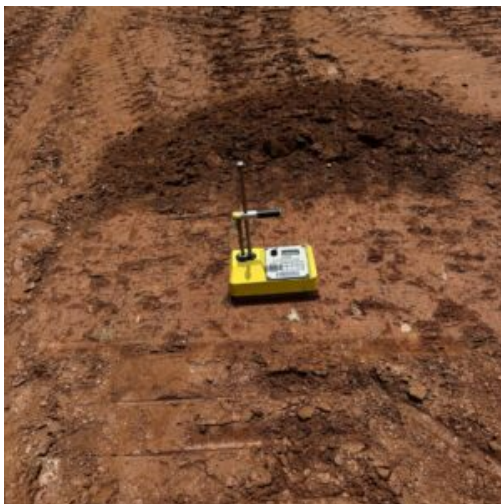
For the road area, fill material was delivered and placed by the contractor using an articulated dump truck. The material was spread and graded with a crawler bulldozer. The placed material was then compacted using a sheep-foot roller with multiple passes performed. Field density tests were performed on the compacted fill material. Based on the test results, the compacted fill met the project-required compaction specifications.
