Date : 07/20/2026  
Project No : 2025C214  
Client Company : Artisan  
Arrival Time : 07/20/2026 06:30  
Onsite Hours : 05:30

ASEC Report ID : 96312  
Name of the Project : NW Unit 4 BRIDGE (Materials Testing)  
Project Location : Dallas  
Weather : Sunny  
Departure Time : 07/20/2026 12:00  
ASEC Technician Name : Clyde Smith

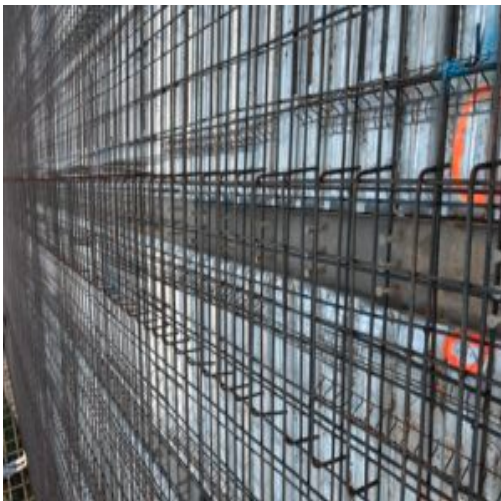
Reinforcing steel in place at panels deck

The writer reobserved placement of reinforcing steel for the bridge panels prior to concrete placement. Discrepancies observed on 7/17/26 were corrected.

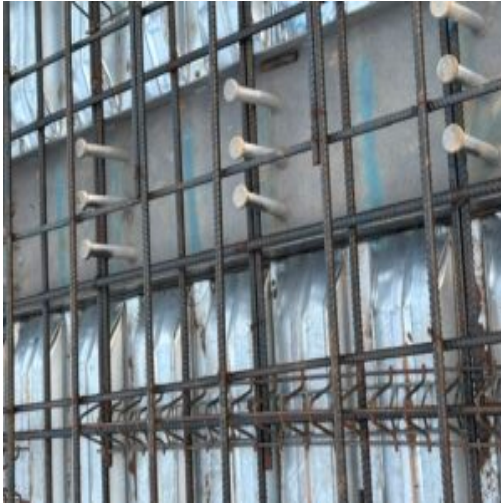
Resteel observations panel decks were cleaned

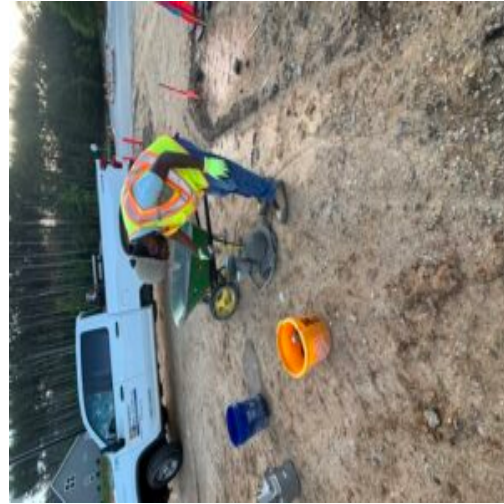
Sampling of placed concrete

On the above date our representative was on site to observe and assist in and testing concrete for the pour for the bridge slab deck pour of 135 cubic yards. Assisted in molding three sets of (6) 4 x 8 cylinders. See additional report dated today by ASEC technician.

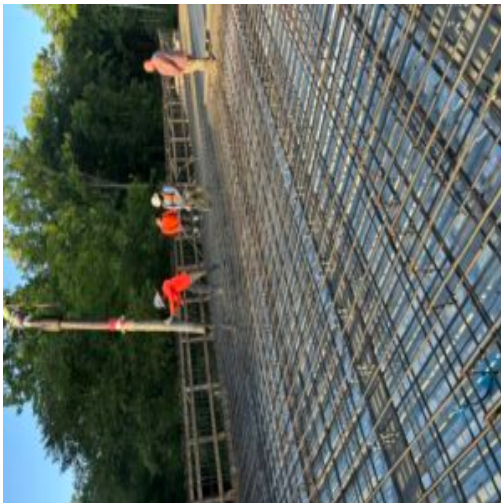
Concrete placement at sidewalk

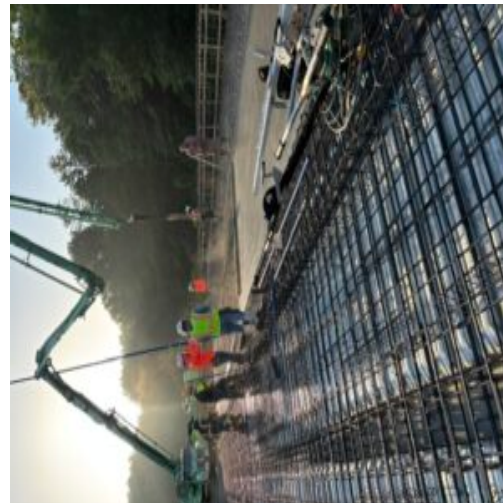
Concrete placement by pumping

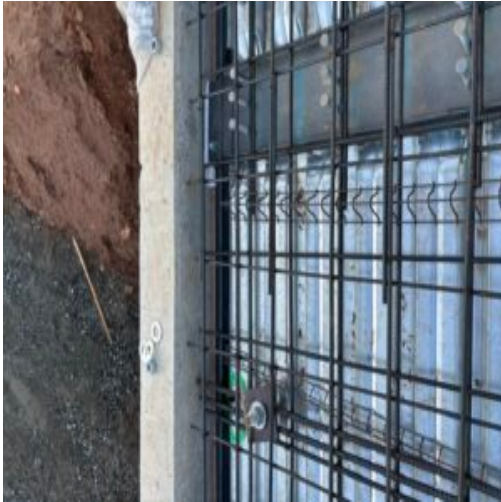
#6 vertical bars in place at support dowel rods manhole # 12 which clipping was recommended to repair from rain events and construction traffic

The writer also observed proof-rolling of the remaining damaged subgrade soils to sanitary sewer manhole #12 using a loaded tandem dump truck loaded with 18 plus tons. The subgrade was also observed by members from NWGP who began repair measures clipping damaged subgrade soils to replace with additional base stone. The contractor clipped out a section today recommended for 4" placing six loads of base stone with contract base stone included.

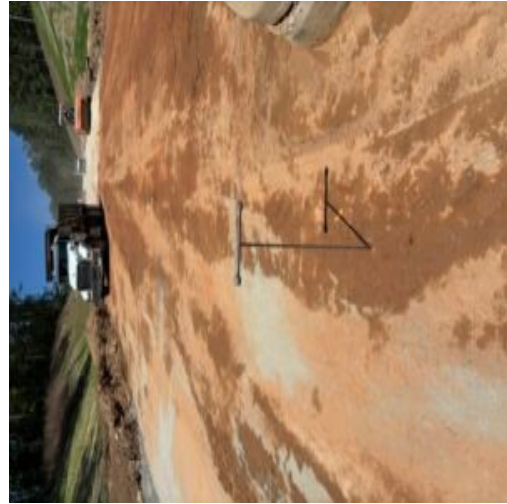
Observing proof of remaining subgrade to sanitary sewer
