Date : 08/18/2026  
Project No : 2026C101  
Client Company : Artisan  
Arrival Time : 08/18/2026 07:30  
Onsite Hours : 07:00

ASEC Report ID : 96999  
Name of the Project : Seven Hills PHASE 13, UNIT 3 Lots  
Project Location : Dallas  
Weather : cloudy  
Departure Time : 08/18/2026 14:30  
ASEC Technician Name : N/A

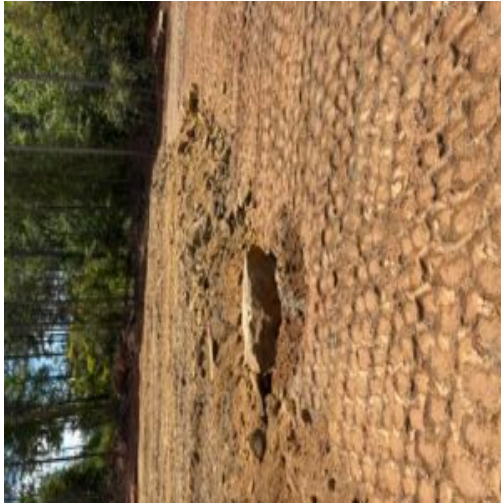
Fill placement at Unit4 phase3 future lots with large boulders.

The writer also observed the grading contractor Thompson continue placing fill at unit 4 phase 3 future lots. The contractor was placing fill soils containing large boulders and is requesting lot numbers or elevations to determine suitability of fill placement. The contractor was reminded that boulder fill should not be placed within the top four feet of finished subgrade for the building lot pads.

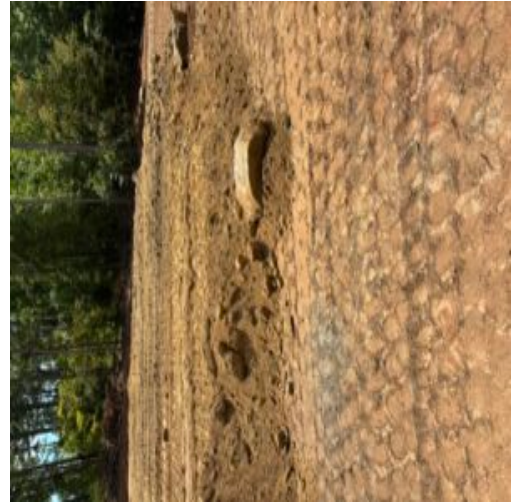
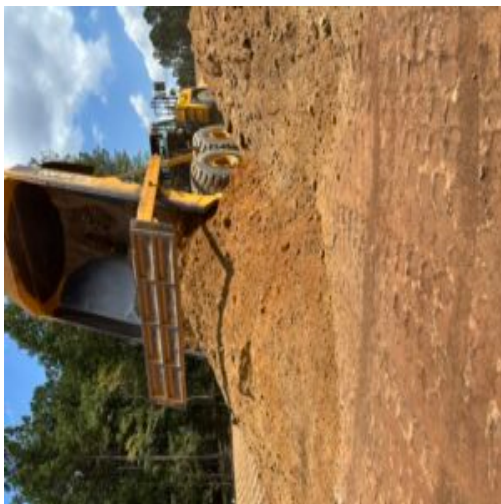
Fill placement at Unit 4 phase 3

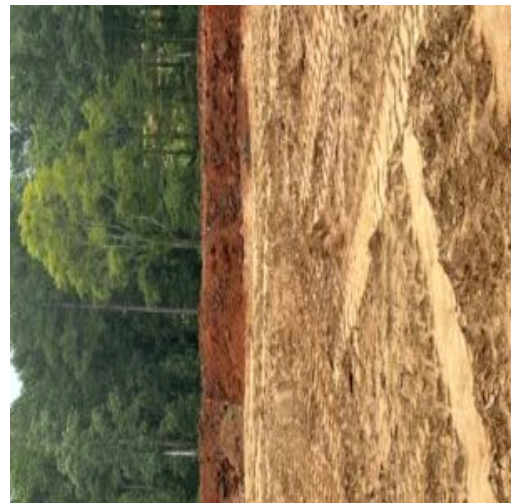
Slope embankment fill at roadway near detention pond between B6 ST JB and B5 ST JB. Thick lift with limited compacting efforts

The writer observed the grading contractor Thompson continue placing topsoil materials in thick lifts with minimum compacting efforts. The contractor was reminded that in the slope embankment compacting efforts are required. This material was being placed at elevation -12 feet.

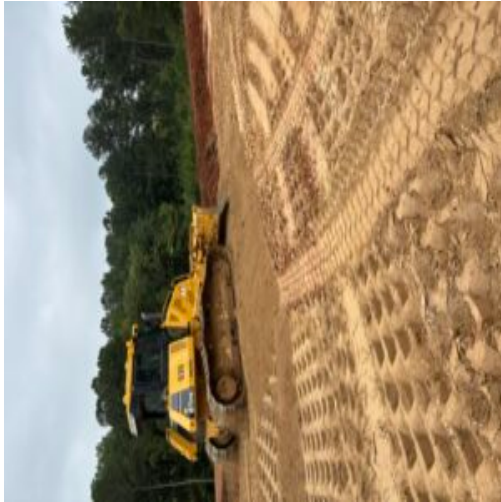
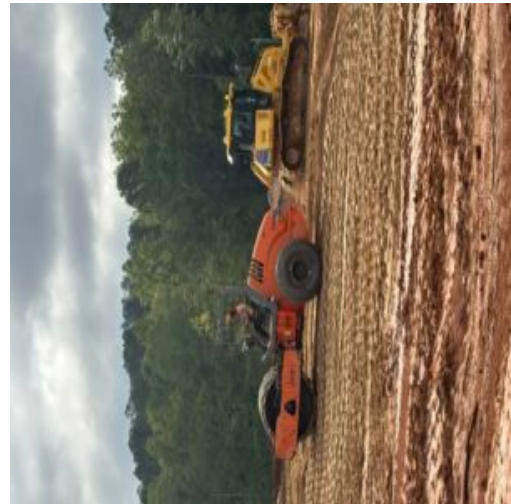
Fill placement at roadway

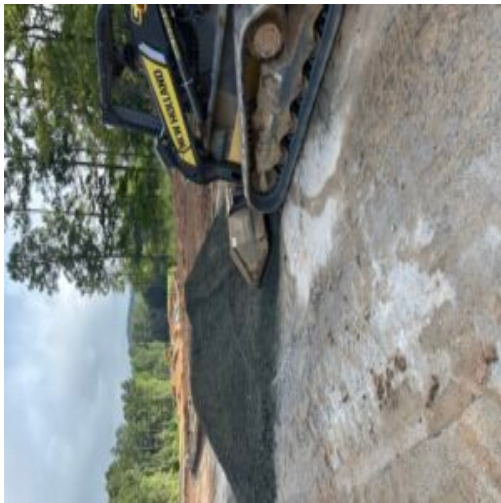
Sub base stone placement at roadway phase 13

On the above date our representative was on site to observe the paving contractor J&W continue subgrade preparation for the roadway starting above the Plantation Gas lines to the cul-de-sac after a rain event late in the afternoon on 8/17/26. The contractor clipped an additional -2" of existing subgrade saturated soils to be replaced with additional base stone. The contractor began placing base stone over approved subgrade soils pushing out over the subgrade as recommended.

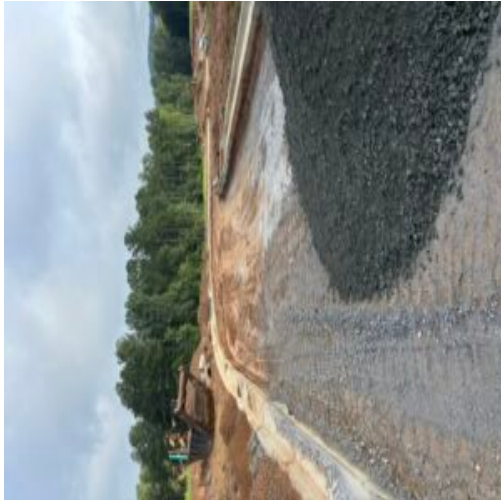
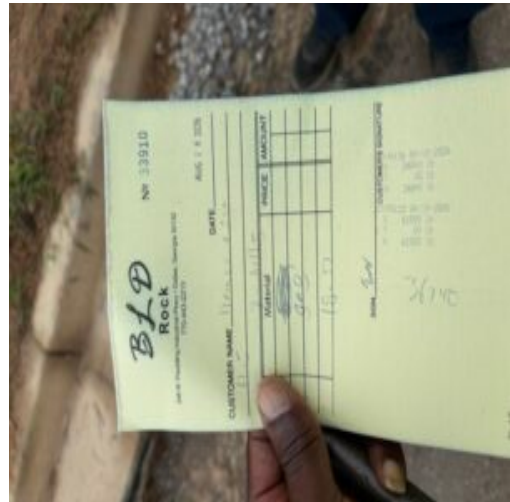
Truck ticket with 18 plus tons for proof roll
